Project Summary  
and Design  
Recommendations  
Revision # 1

Pelican Reef Residential Subdivision

Project # 18-024

Dated: November 14, 2018

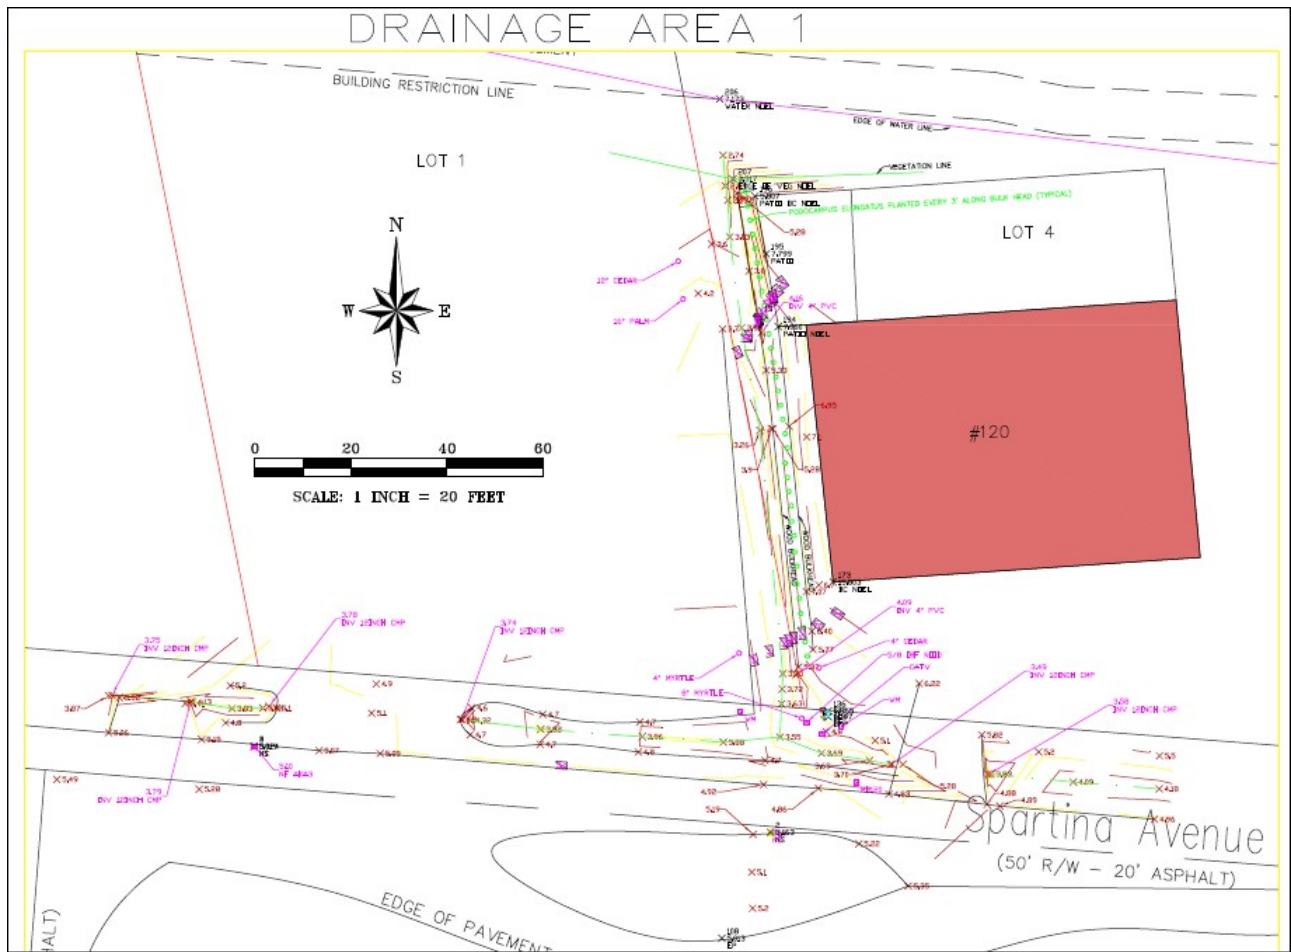
Figure 8: Drainage Area 1

The first location of the concern is on Spartina Avenue, opposite of the stormwater treatment pond.

There is an existing easement between Lots 1 and 4, that runs from the Spartina Avenue to the wetland. There is a concrete catch basin structure within the Spartina Avenue that collects the local stormwater flows. Adjacent to the catch basin is a high point, that redirects the stormwater flows away from the catch basin, See Figure 9 below. There is a high spot in the swale which is directly t causes the stormwater flows from the culverts to not flow downhill. This highpoint is shown in Figure 9. We also were able to find the discharge

- a. Flush and vacuum clean the +/- 120-foot storm drain line from catch basins to the wetland. This will allow the condition of the pipe and record that the pipe is clear, for the length of the pipe.
- b. The culvert discharge pipe should have a headwall installed, to protect the upland, and a scour pad to dissipate the stormwater flow energy. This work can be completed with concrete rip-rap bags to be assembled in the field. The concrete rip-rap can be hand carried and assembled without heavy equipment.

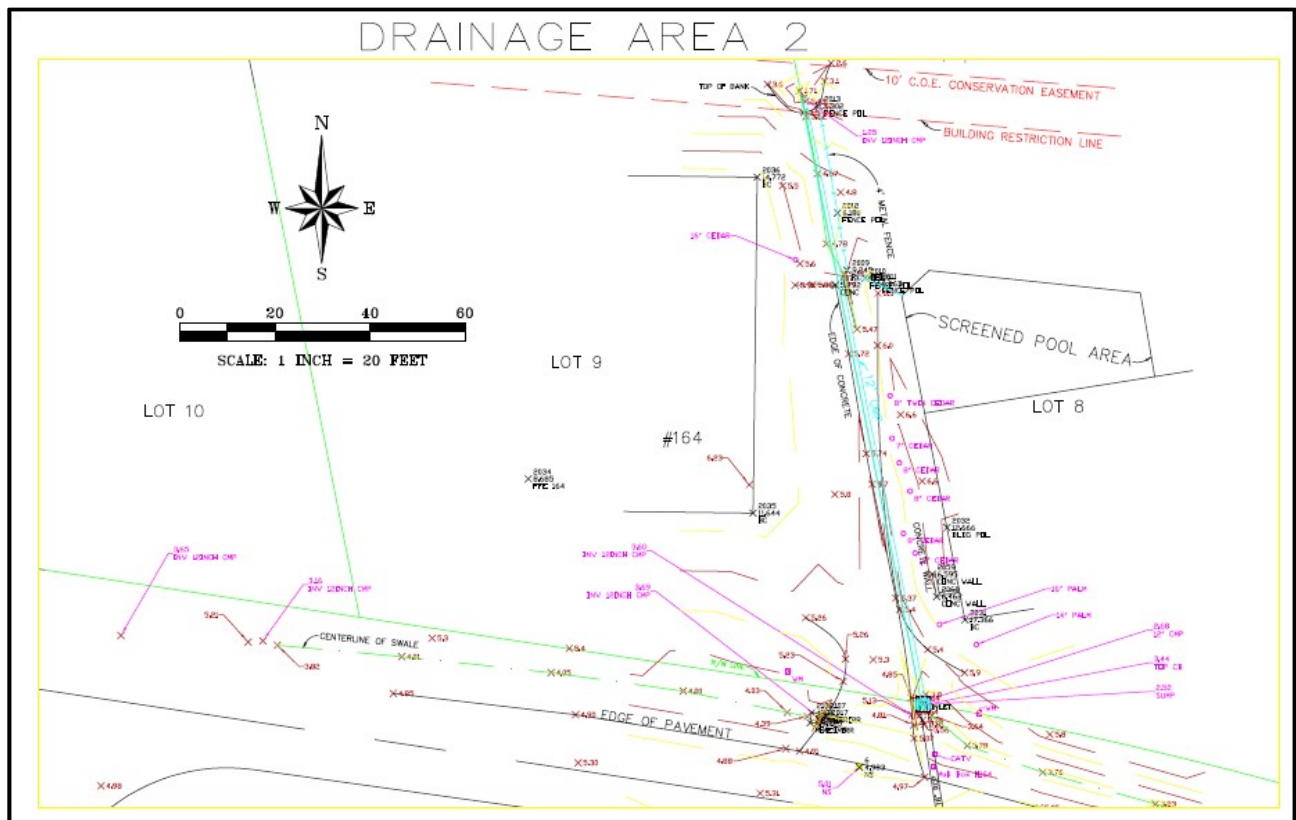
Figure 12: Drainage Area 2

The Drainage Area 2 illustrates the watershed connection to the Drainage Area 1, to the stormwater pond. This swale is connected to a catch basin that discharges in the stormwater pond.

The stormwater pond, shown in Figure 12, where discharge pipe is underwater. The scale collects stormwater flows into the collection catch basin.

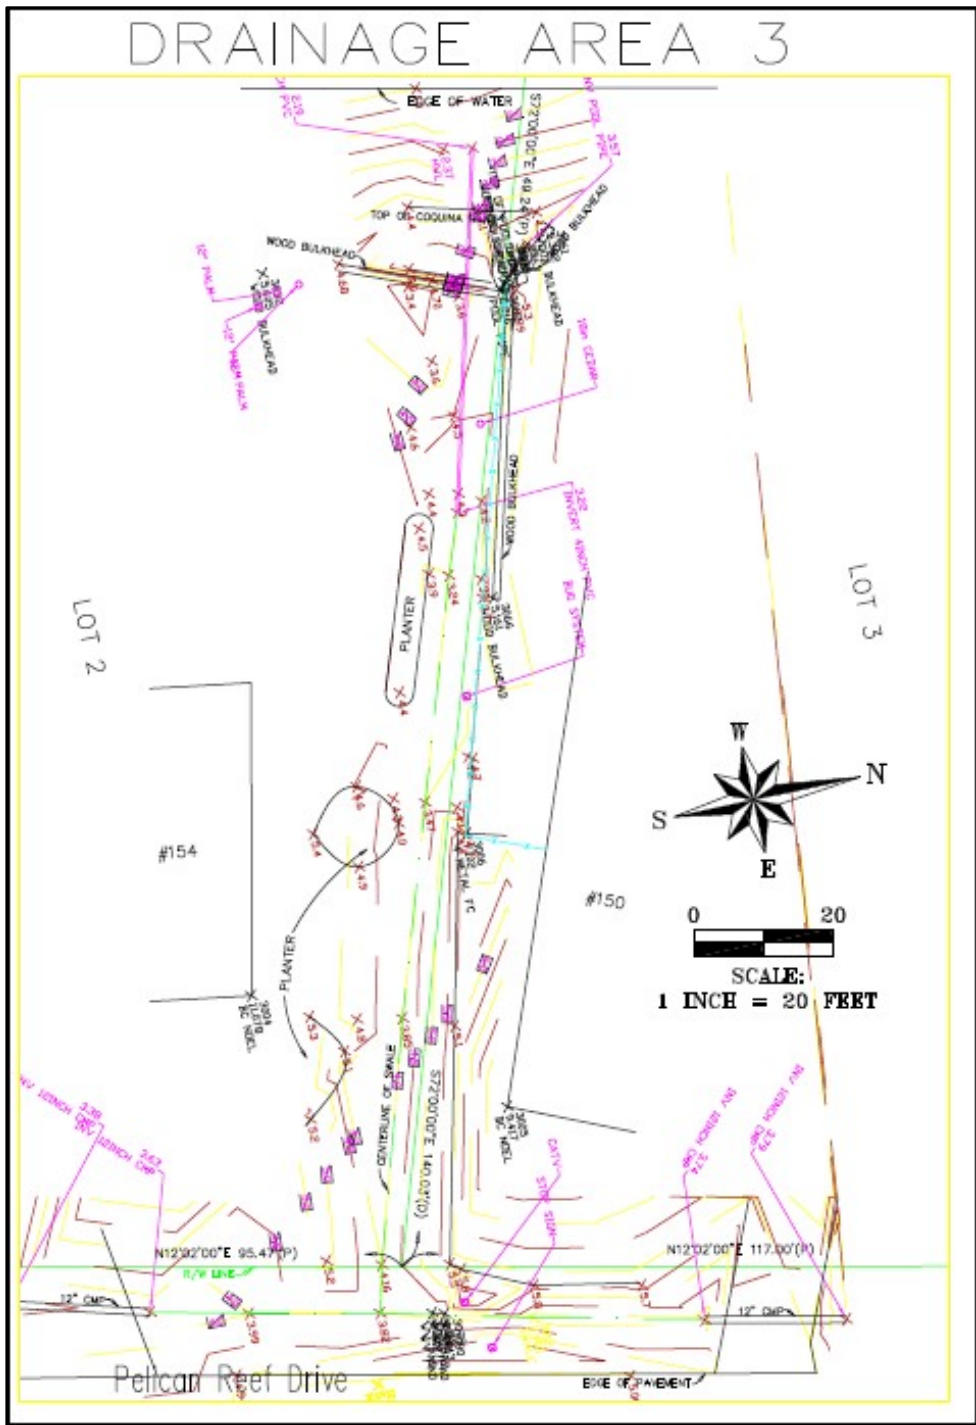
Figure 17: Discharge Area #3.

The Drainage Area 3 illustrates the watershed connection to the Matanzas River from Pelican Reef Drive. This swale is connected to a catch basin that discharges in the stormwater pond and shown in Figure 17.

The swales on the east side of Pelican Reef Drive collection from the both north and south, to the drainage swale that discharges to the Matanzas River.

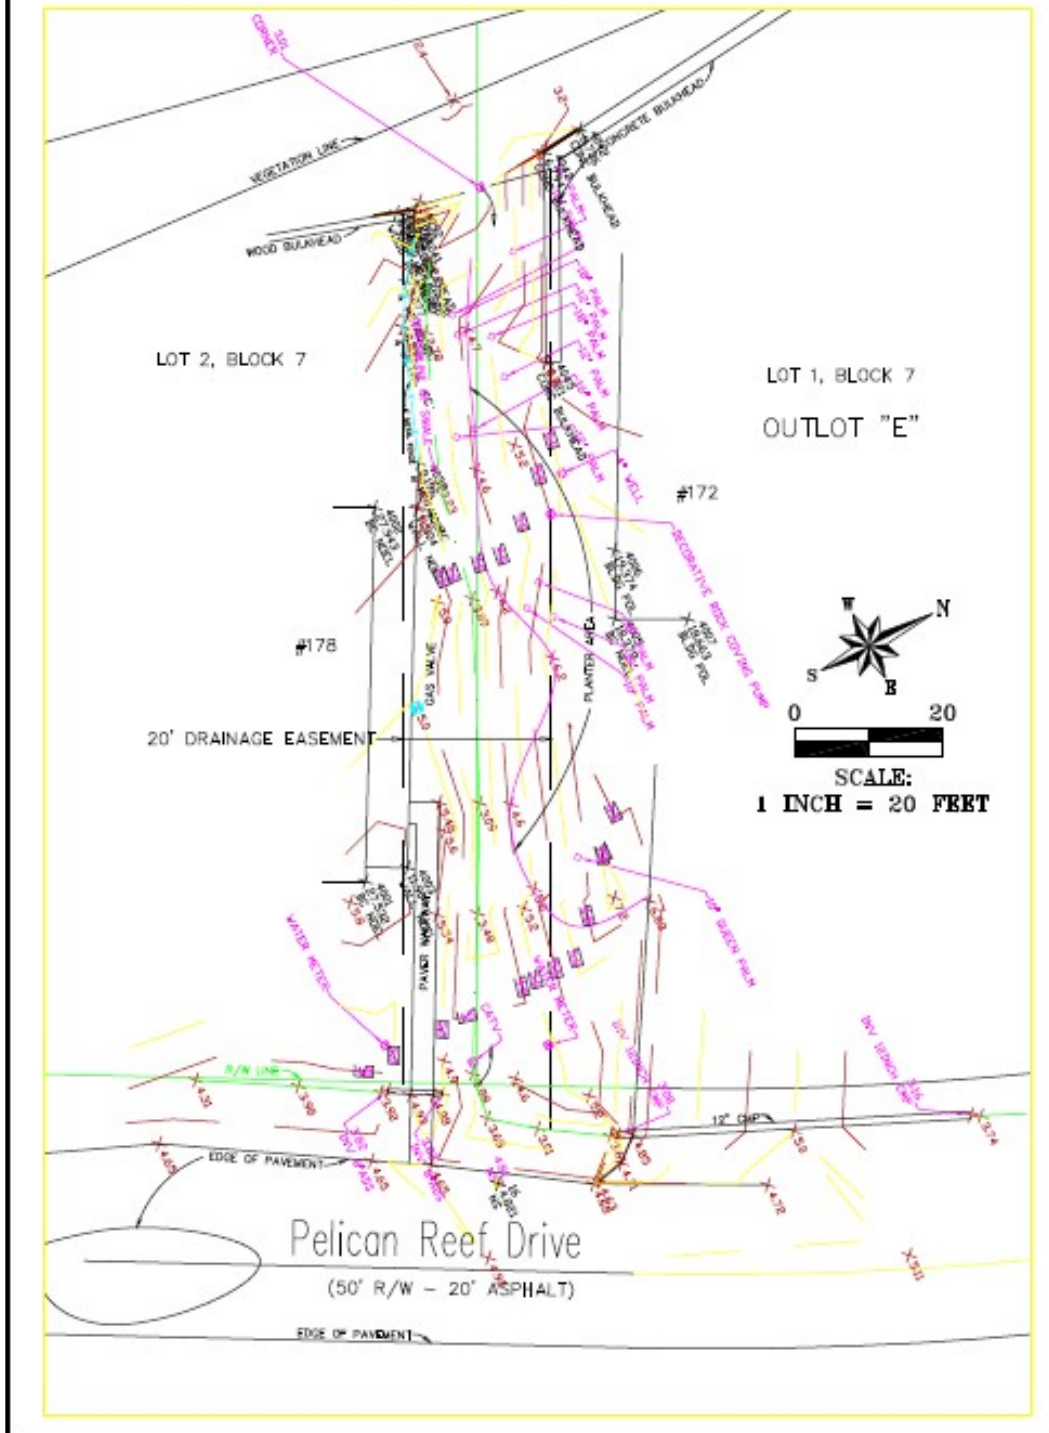
Figure 20: Drainage Area #4

The Drainage Area 4 illustrates the watershed connection to the Matanzas River from Pelican Reef Drive, and is shown in Figure 20. This drainage easement has been blocked with a raise grades, and vegetation, and there are areas with mulch and erosion. There is a box in the middle of the swale by the drain causing drainage issues by blocking swale flow. A pool drains blocked discharge swale, and adds more water to a blocked system.

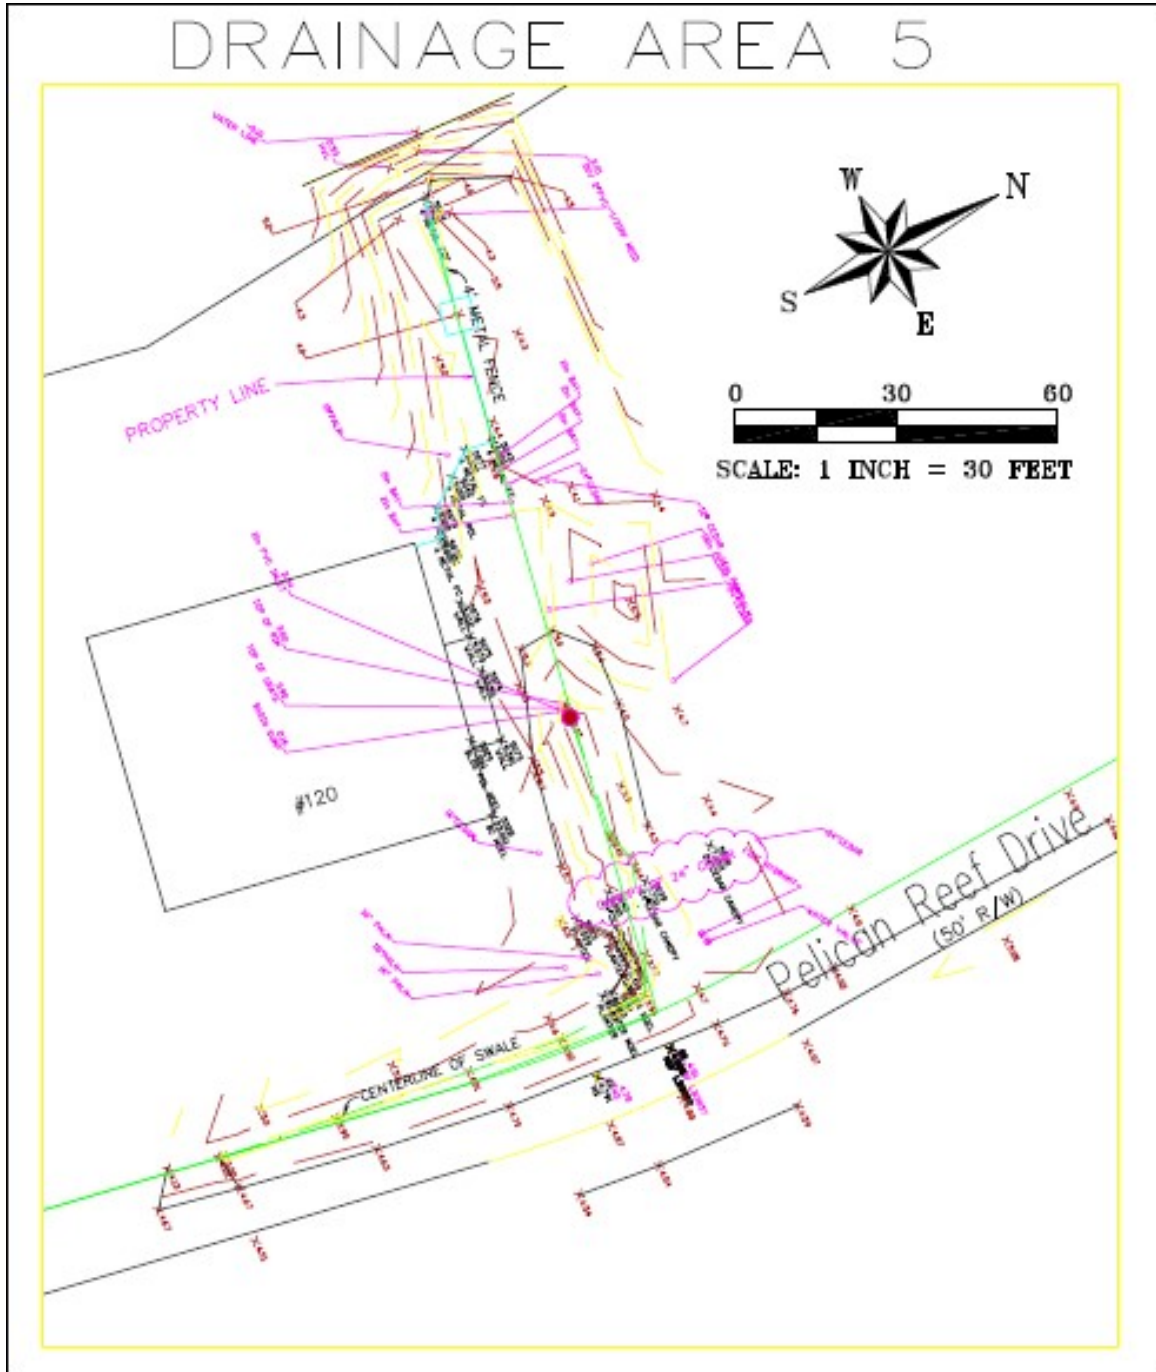
Figure 31: Drainage Area #5

The Drainage Area 5 illustrates the watershed connection to the Matanzas River from Pelican Reef Drive and is shown in Figure 31. This drainage easement has been blocked with a raise grades, and vegetation, and there are areas with mulch and erosion. There is a box in the middle of the swale by the drain casing drainage issues by blocking flow and a pool drain blocked discharge.

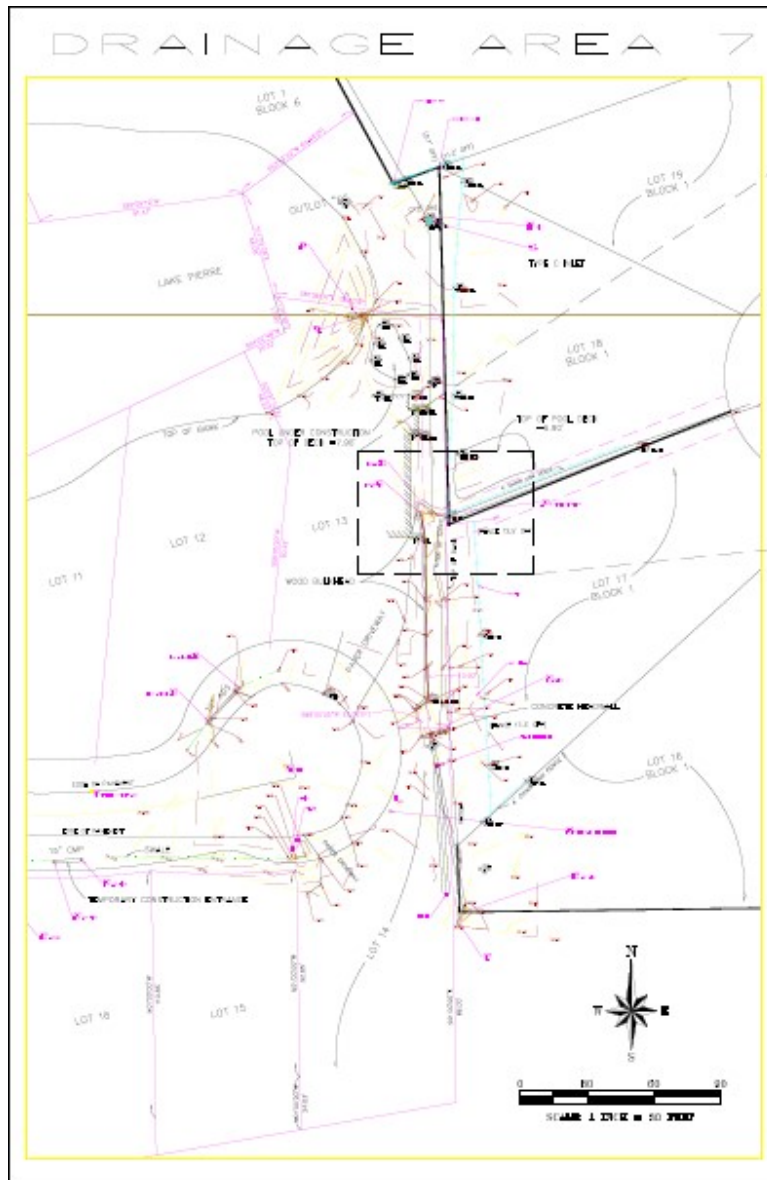
Figure 34 Drainage Area #7

The Drainage Area 7 illustrates the watershed connection to the Matanzas River from Pelican Reef Drive as shown in Figure 34. This drainage easement has been blocked with a raise grades, and vegetation, and there are areas with mulch and erosion.

- a. Flush and vacuum clean the +/- 120-foot storm drain line from catch basins structure. This will allow the condition of the pipe and record that the pipe is clear, for the length of the pipe.
- b. Clean the catch basin and the pipe from the swale to the Lake Pierre discharge. Install concrete rip-rap headwall on the intake pipe from swale.
- c. The swales adjacent to the catch basin should be sloped to the catch basin at a 1% slope toward the discharge wetland.

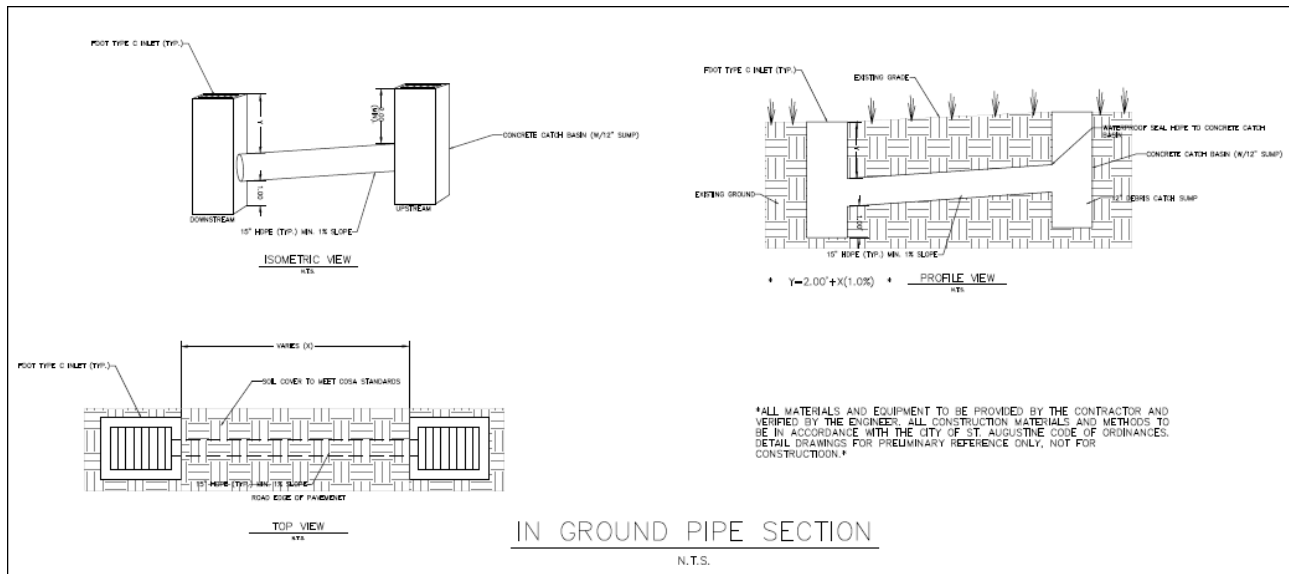
Figure 35: Sketch of In ground pipe sections

This system shall be water-tight. The project's drainages system is currently inundated with ground water, and inhibiting the system flow.

Figure 35, below illustrates the proposed catch basin and culvert installation connections.

The Replace the Existing Culvert Pipe Task with Catch Basin Installation, is the construction task to remove and replace undersized, clogged, or culverts that slope in the opposite direction of the hydraulic grade line. This task's cost includes the excavation of the existing pipe, removal of pipe, backfill, compaction, and the installation of new 18-inch diameter High Density Poly-Ethylene Pipe (HDPE) with the appropriate cover, and restoration to the existing conditions. We have estimated installation costs for these tasks to be \$85.00 per l.f.
