## SITE VISIT MEMORANDUM

**Project #: 18-024 (Pelican Reef)**

**Subject: Present Site Conditions**

**Date: May 10, 2019**

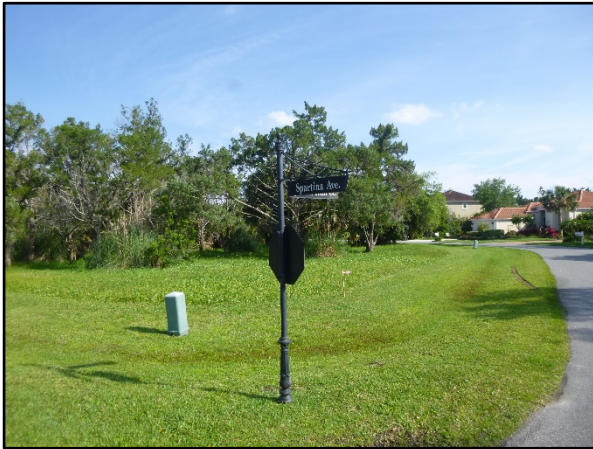
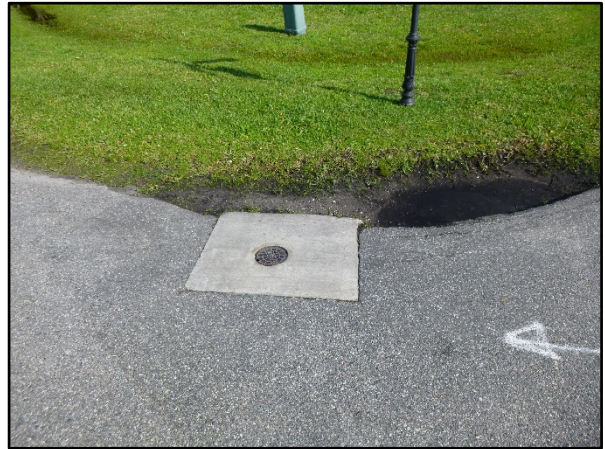
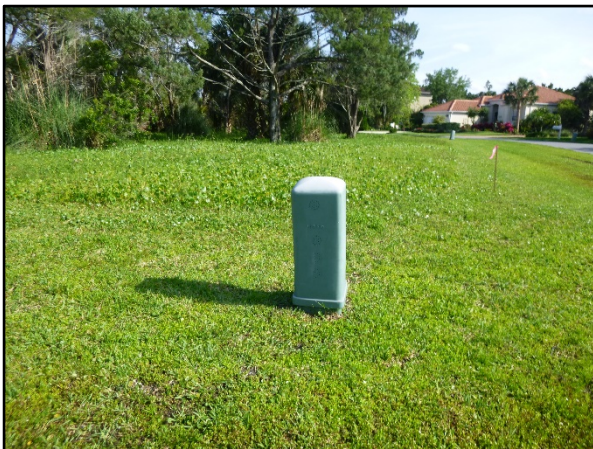
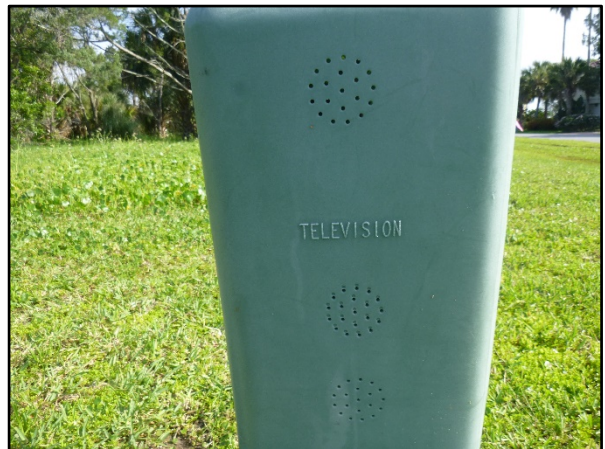
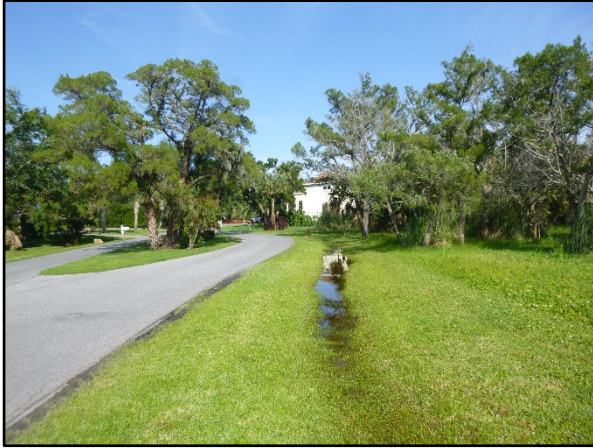
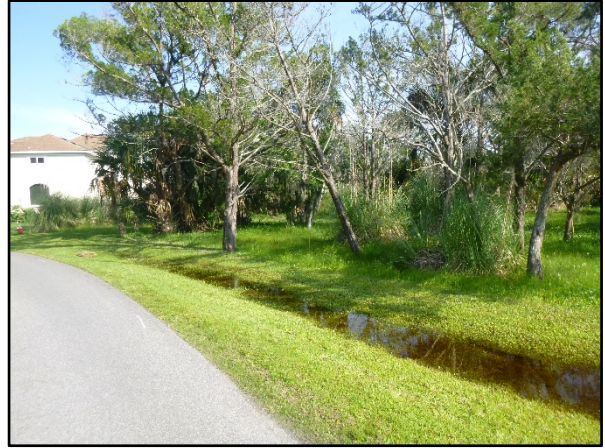
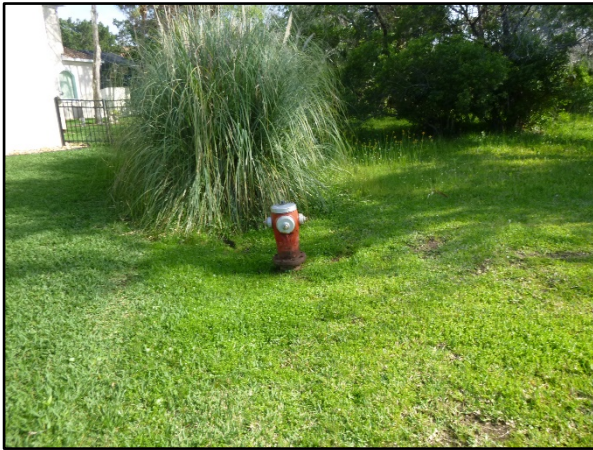
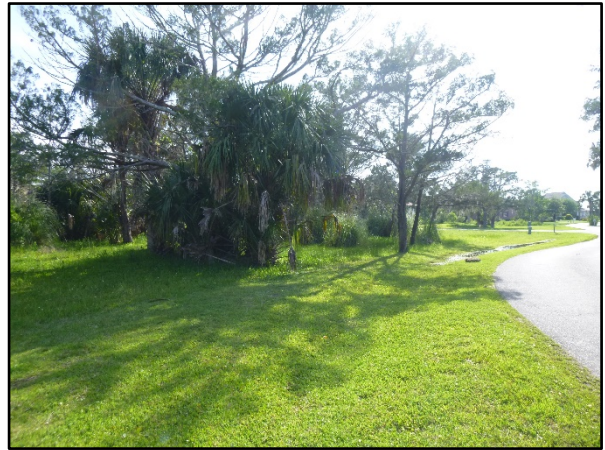
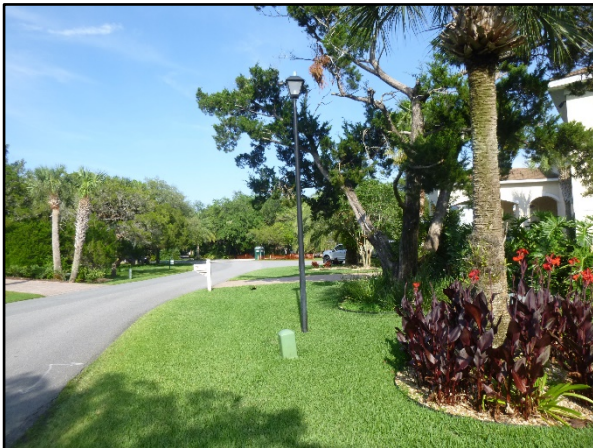
### **PROJECT AREA 3 (Pictures 1-9):**

- Swale in project area appears to be wet; however, limited standing water is observed directly within the project boundary.
  - Standing water was observed more so to the East of the project area (towards the front of the Sub Division).

- Street lighting and a Fire hydrant identified to the East of the project area.
- Existing water valve located at the intersection of Spartina Avenue and Spoonbill Court.
- Television service boxes located within the project area.

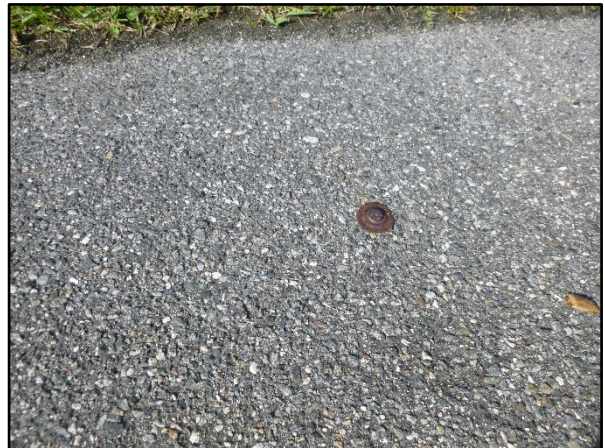
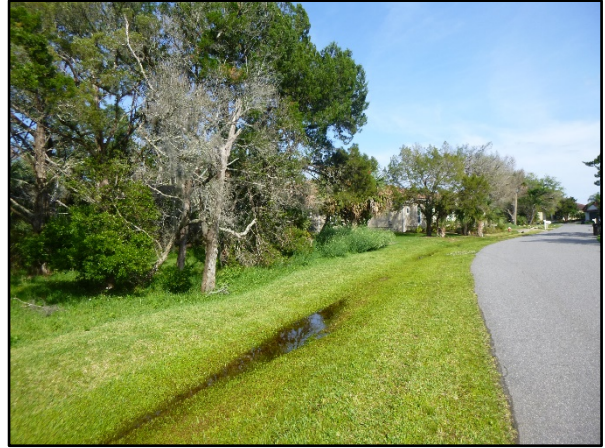
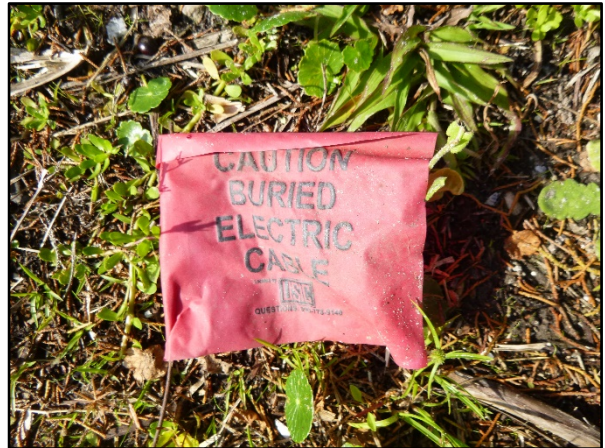
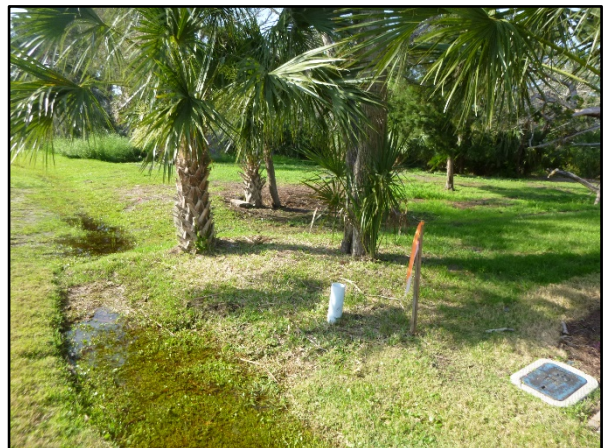
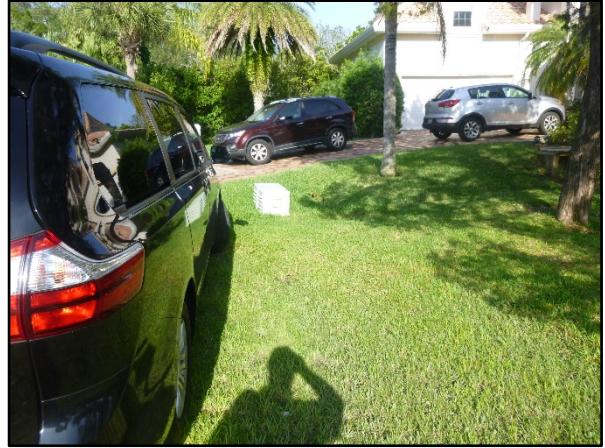
### **PROJECT AREA 2 (Pictures 10-17):**

- Project area 2 had an observed survey benchmark along the eastern side of Spoonbill Court.
  - This project lies on and within the bounds of “vacant lots”
- Standing water was present within the existing swale.
- A television service box is located to the North of the project site.
- A cable service was flagged in the field to the South of the project site.
- Existing water services (meter boxes) were identified to the South of the site.

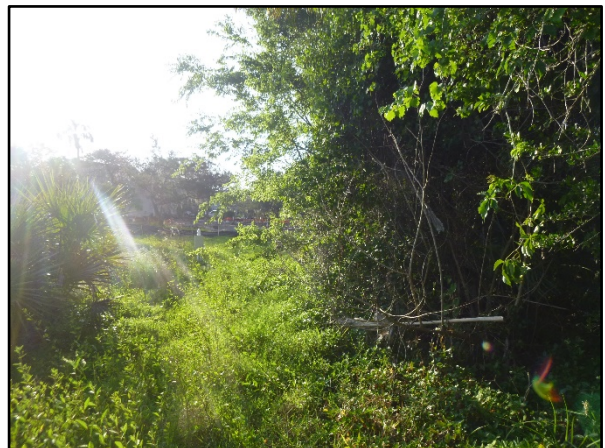
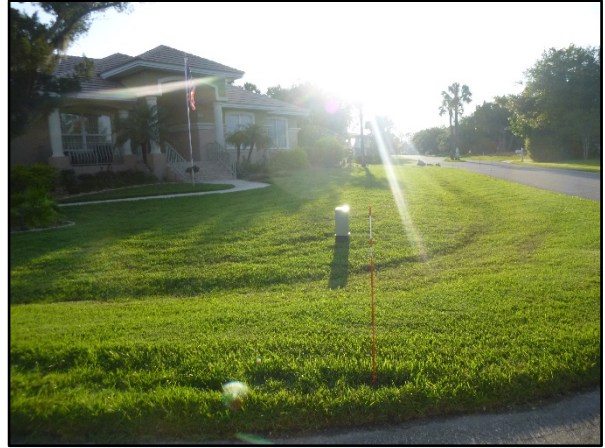
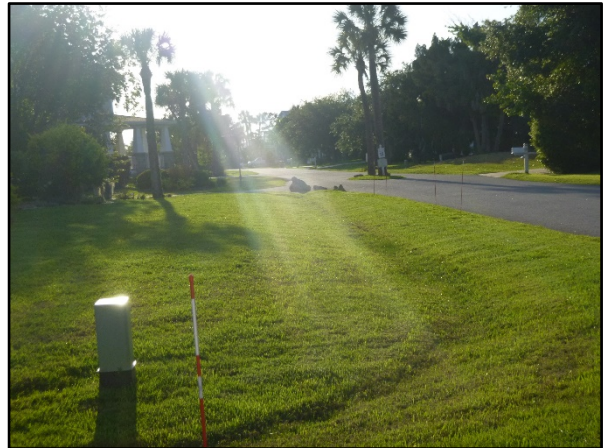
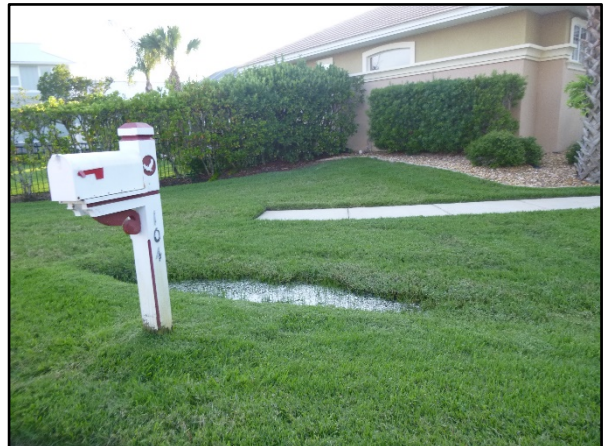
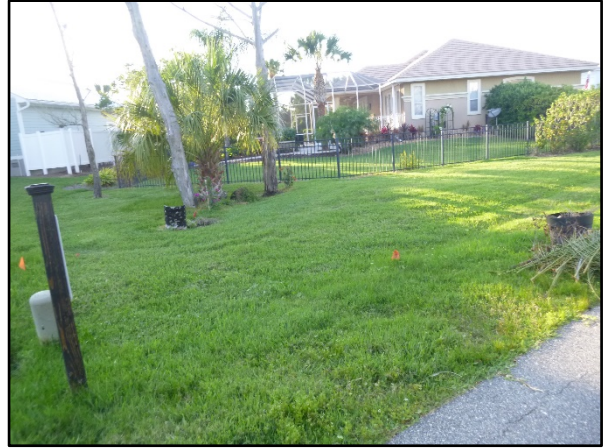
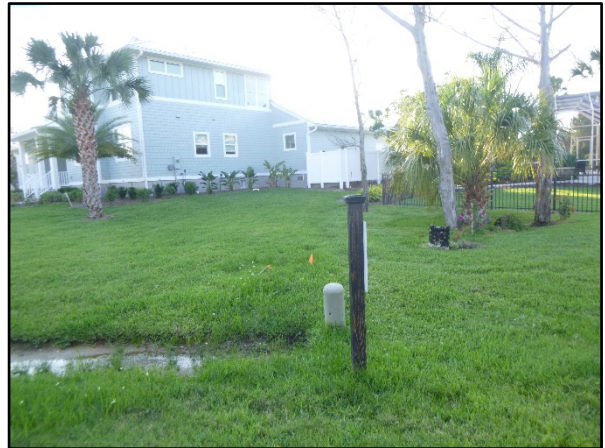
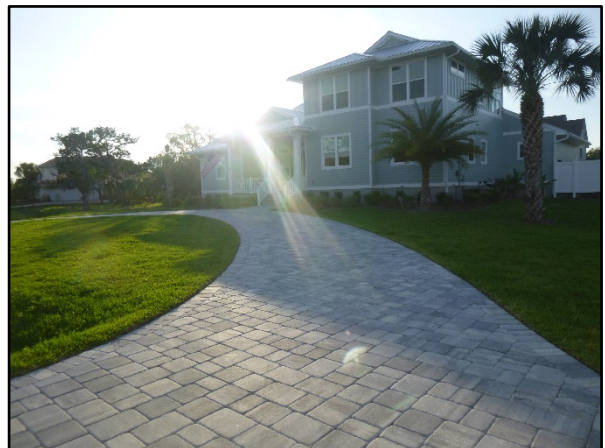
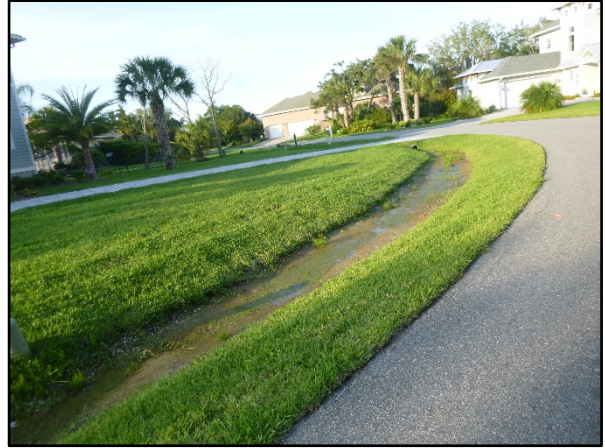
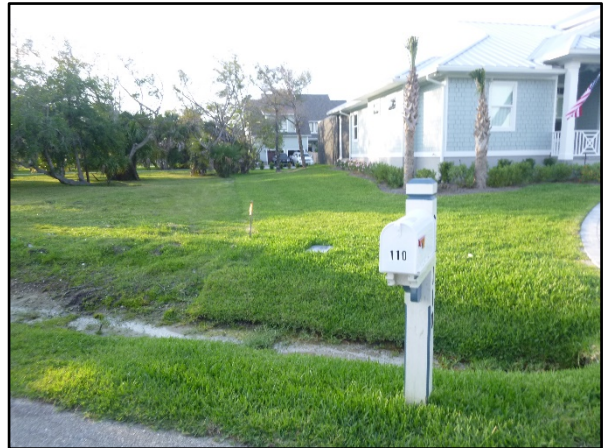
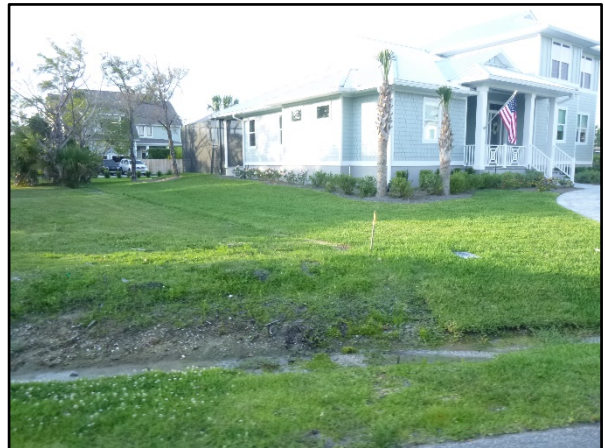
**PROJECT AREA 5 (Pictures 35-54):**

- Landscaping encroaches near roadway and could interfere with instillation of storm structures or piping.
- Driveways
  - One concrete driveway and one paver driveway
    - Paver driveway has a (appears) new Mitered end section discharging to the neighboring property. It is not evident whether this drainage is consistently positive. However, during the time of the site visit, there was limited standing water observed in the area.

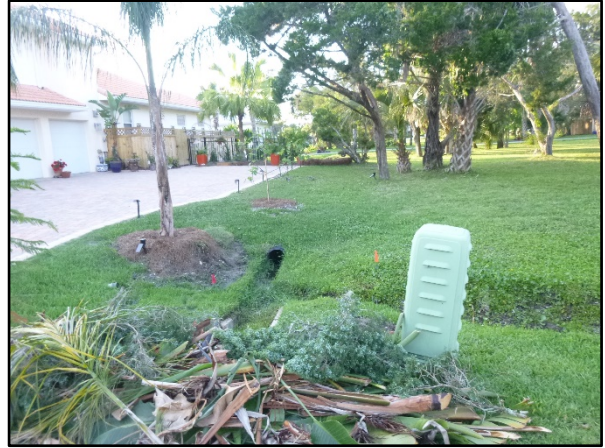
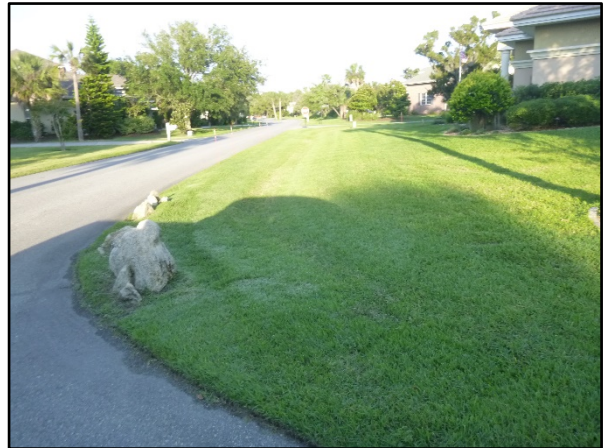
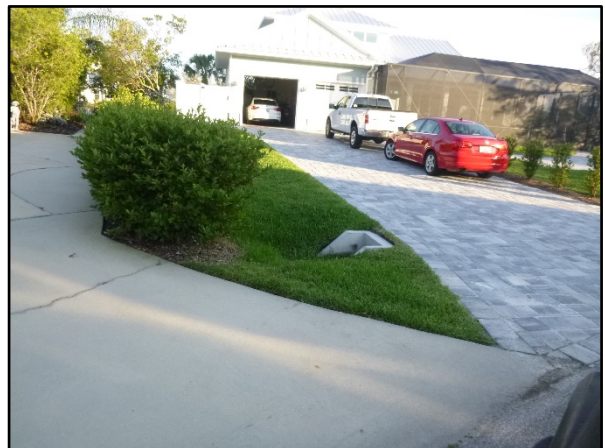
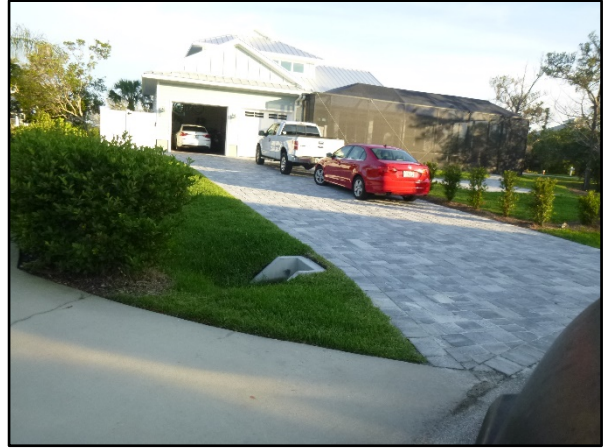
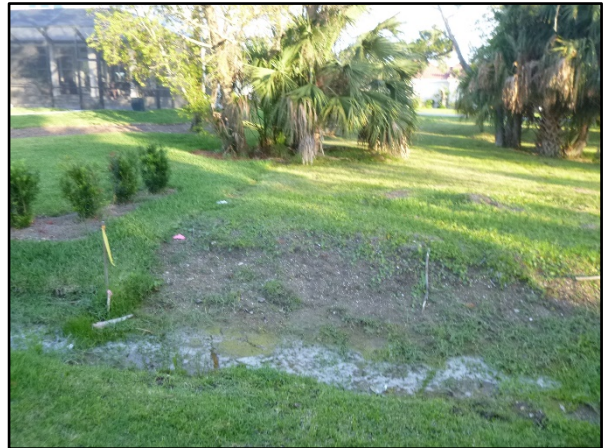
**PROJECT AREA 4 (Pictures 55-63):**

- Swale located at the intersection of Oyster Catcher Circle and Spartina Avenue
  - Standing water increases where swale has a depth variance closest to 104 Oyster Catcher Circle mailbox (appears to be an underground pipe discharging improperly)
  - Television service boxes are located outside of the swale, on a developed lot.
- Two separate paver driveway sections (same lot) will need to be removed in order to allow for pipe installation.
  - Underground pipe section is located beneath paver driveway section discharges to a shallow non sodded area with utility service box adjacent.
  - Cable services were identified as being within the project area.
  - Water service (meter box) identified at western end of 110 Oyster Catcher Circle lot.

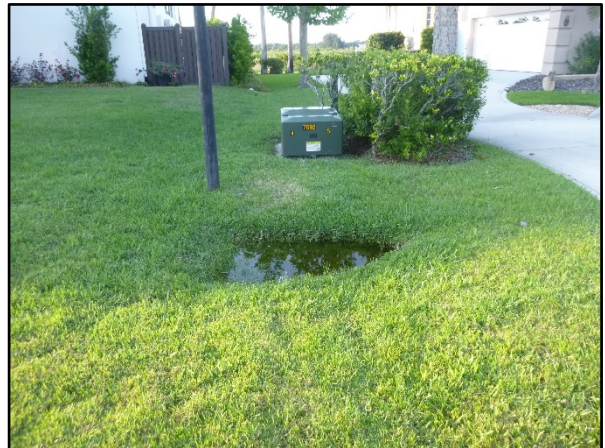
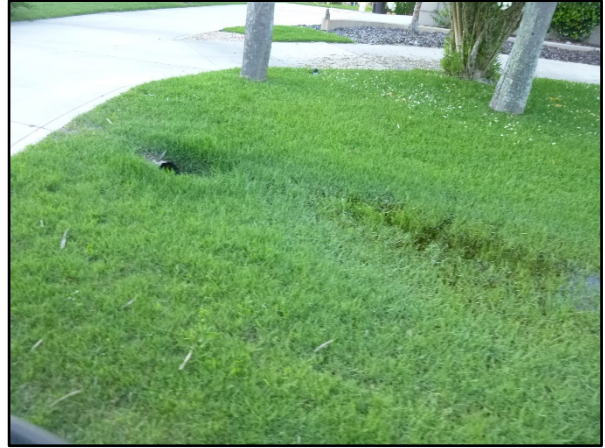
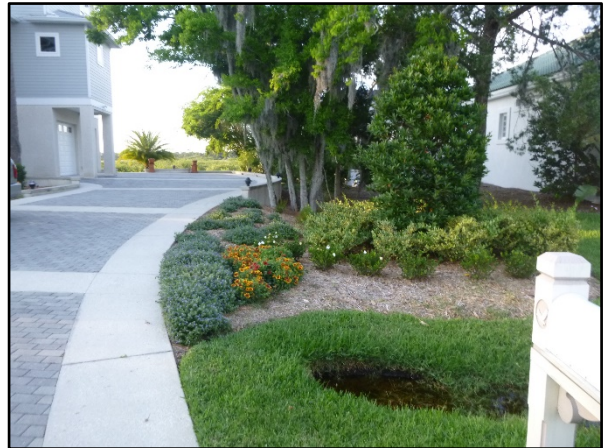
**PROJECT AREA 8 (Pictures 64-70):**

- Driveways
  - 3 Driveway sections will need removed and replaced (2 concrete and 1 paver).
    - 2 Existing type “C” inlets are in place adjacent to the paver driveway section.
  - Underground pipe sections discharges do not connect along the North side of Spartina Avenue.
    - This has created standing water in existing swale areas.
- Telephone service boxes were identified adjacent to the driveways.
- As street light pole and power transformer were identified

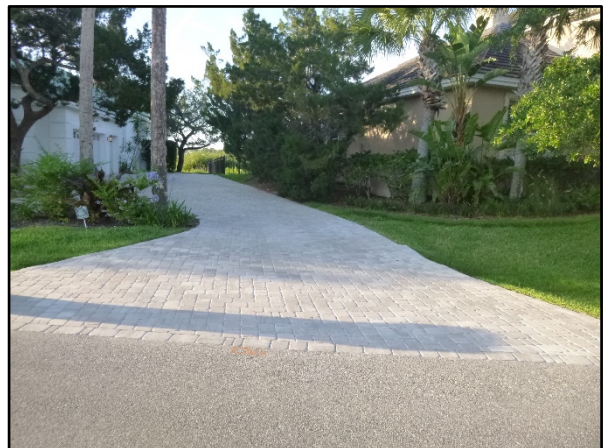
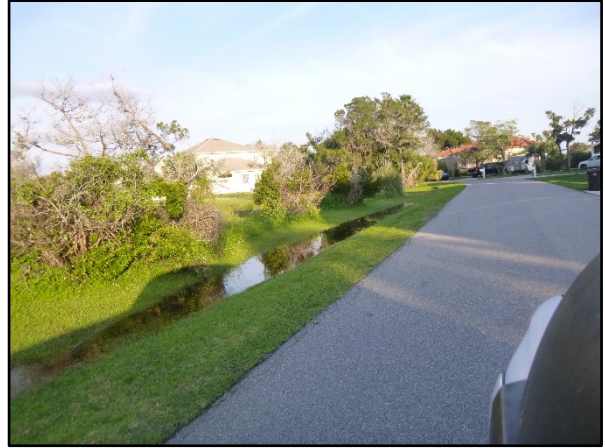
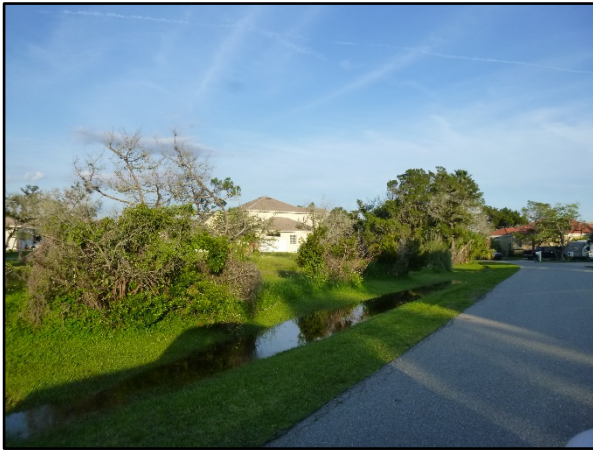
**PROJECT AREA 7 (Pictures 71-74):**

- Existing Swale
  - Swale contains standing water
- Project area lies in the bounds of “vacant lots”
- Water services (water meter) identified at the Northern most boundary to the site.

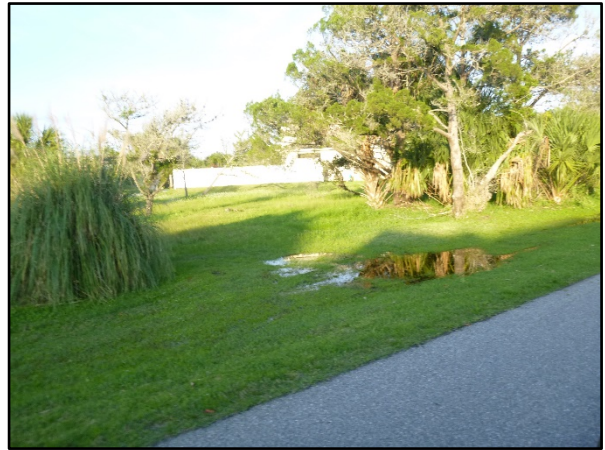
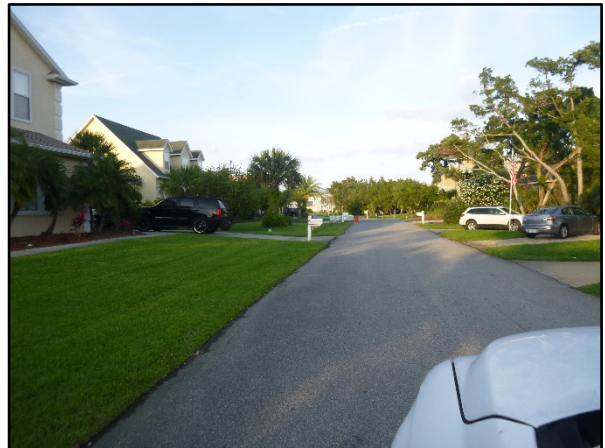
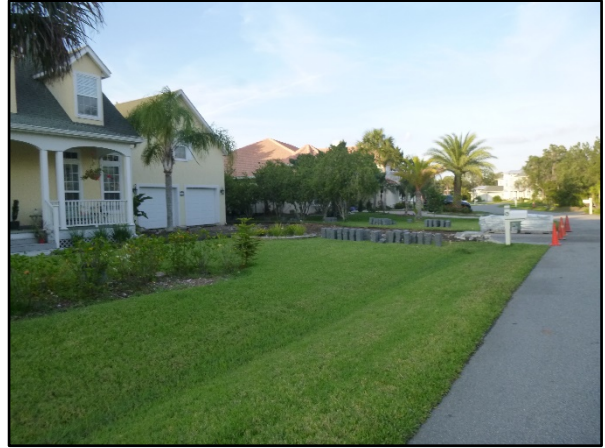
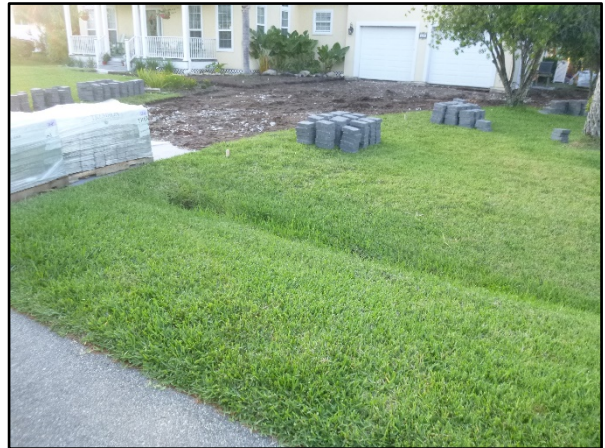
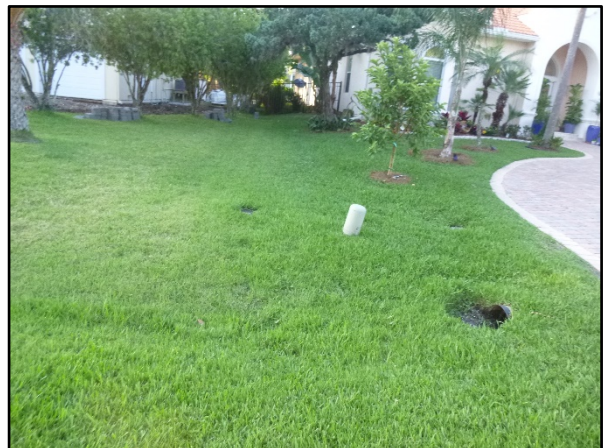
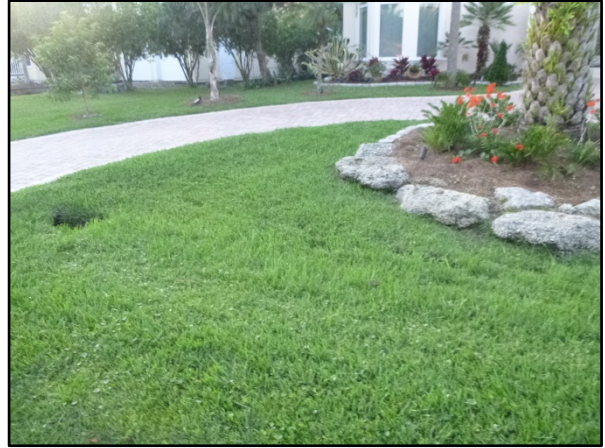
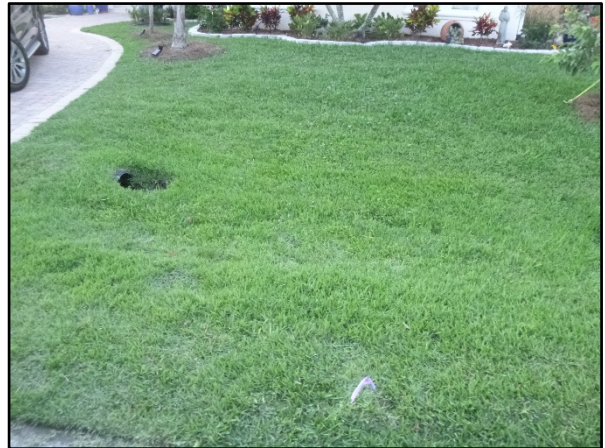
**PROJECT AREA 6 (Pictures 75-87):**

- Driveways
  - There are 6 driveway sections that will need to be removed and replaced to install storm pipes and structures.
- Existing under driveway drainage pipe swales do not connect. Minimal standing water was observed during the time of the site inspection, however, this is prone to produce standing water.
- Existing water services to homes adjacent to the project area should be considered during the construction and bidding process.
- Existing wire utilities were identified to the North of the existing swale.

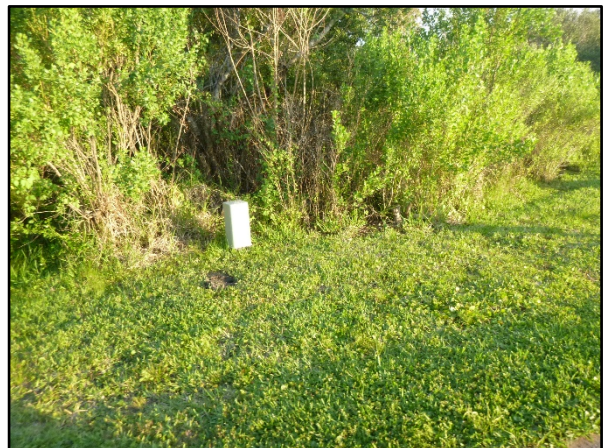
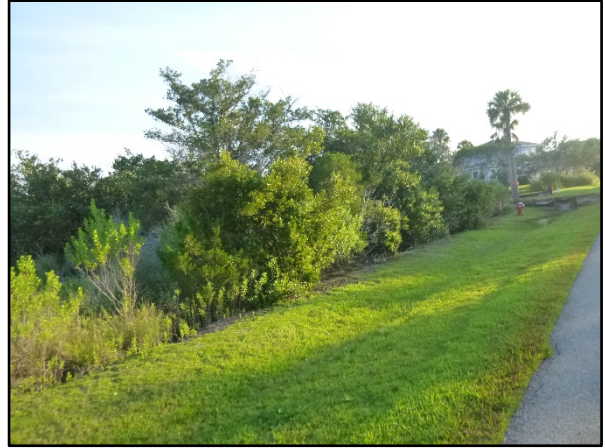
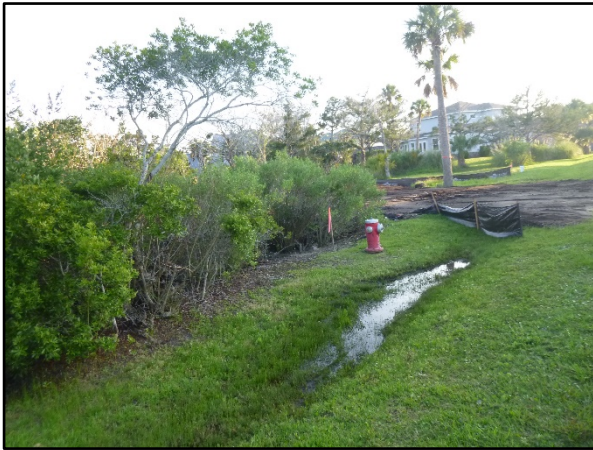
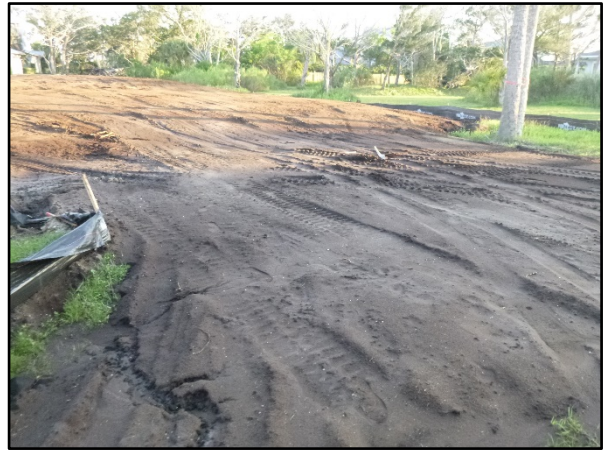
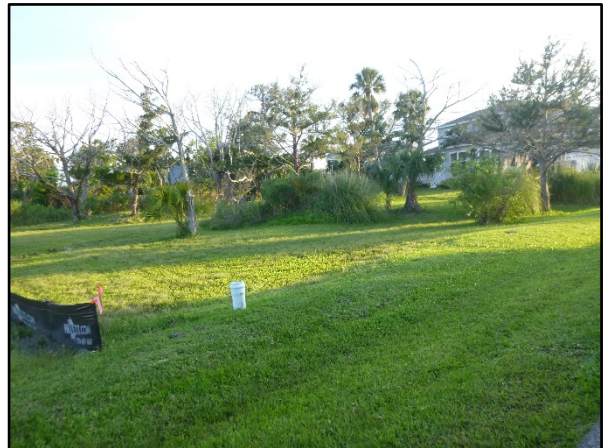
**PROJECT AREA 9 (Pictures 88-94):**

- Existing drainage swale
  - Swale appeared to have limited standing water, water appears to be draining to brush on the eastern side of Spartina Avenue.
  - Utility service (underground wire) and fire hydrant are located to the East and West of the project area respectively

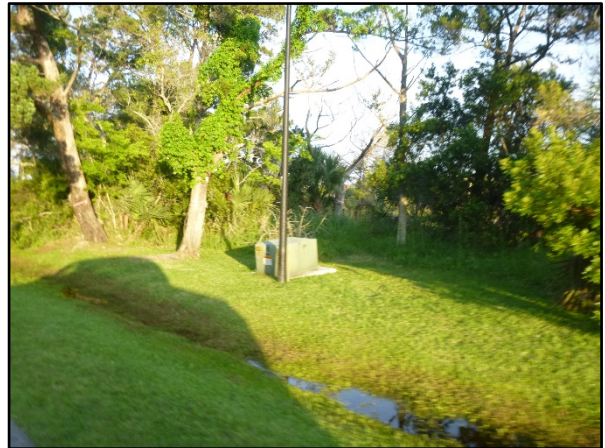
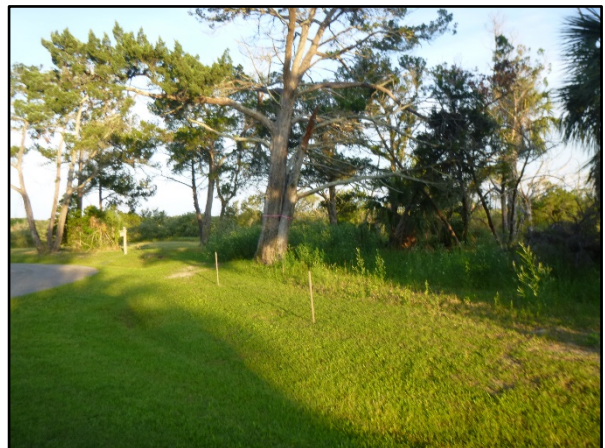
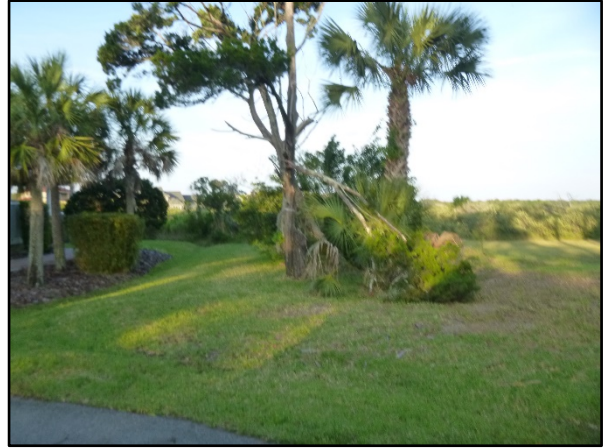
### **PROJECT AREA 1 (Pictures 97-104):**

- Existing Swale
  - Existing swale appeared wet with some standing water to the South side of Fiddler Crab Lane.
  - Identified a light pole and power transformer behind the existing swale.
  - Water service identified on the same side of the swale.
  - Specimen trees observed on the same side of the swale as identified utilities
- Lots on the South side of Fiddler Crab Lane
  - All lots on this side of the road are currently considered vacant.
