Project Summary  
and Design  
Recommendations  
Revision # 1

Pelican Reef Residential Subdivision

Project # 18-024

Dated: November 14, 2018

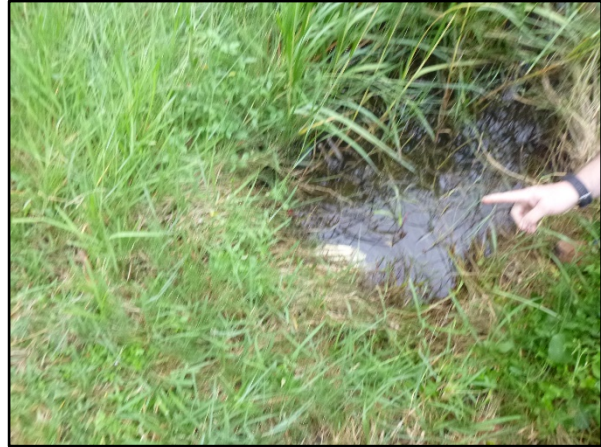
Figure 10: 2018.10.26 18-024- Pelican Reef -121

end of the drainage pipe within the wetlands, see Figure 10. The discharge was clogged with vegetation, and flows were somewhat contained due to the vegetation and sediment within the drainage pipe.

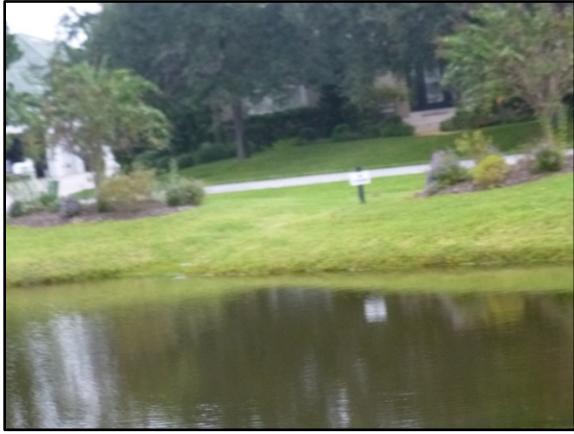
Figure 13: 2018.10.26 18-024- Pelican Reef -176

The stormwater pond, shown in Figure 12, where discharge pipe is underwater. The scale collects stormwater flows into the collection catch basin.

- a. Flush and vacuum clean the +/- 100-foot storm drain line from catch basins to the retention pond on the southside of Spartina Drive, as shown in Figure 12 and 13.
- b. The swale shown in Figure 13, should be cleared, and that the upstream slopes to the catch basin.
- c. The swales adjacent to the catch basin should be sloped to the catch basin at a 1% slope toward the discharge catch basin.

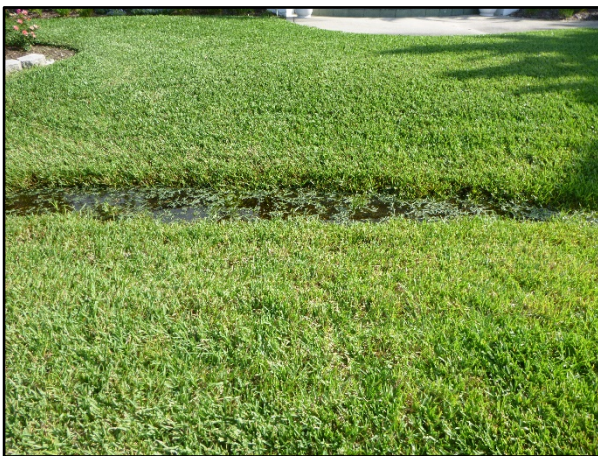
Figure 15: 2018.06.13 - 18-024 - Pelican Reef - 16

The Drainage Area 3 illustrates the watershed connection to the Matanzas River from Pelican Reef Drive. This swale is connected to a catch basin that discharges in the stormwater pond and shown in Figure 17.

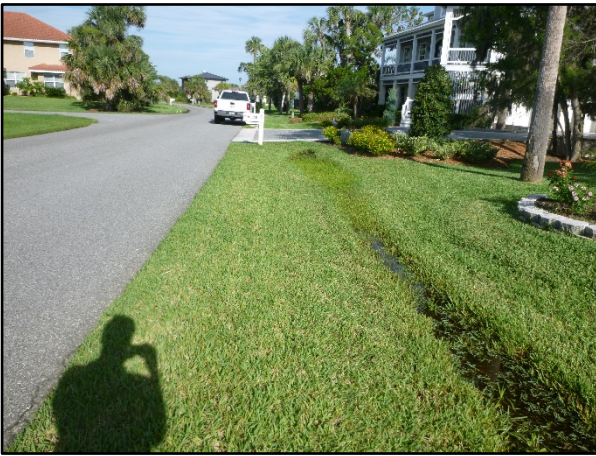
Figure 18: 2018.06.13 - 18-024 - Pelican Reef - 18

The swales on the east side of Pelican Reef Drive collection from the both north and south, to the drainage swale that discharges to the Matanzas River.

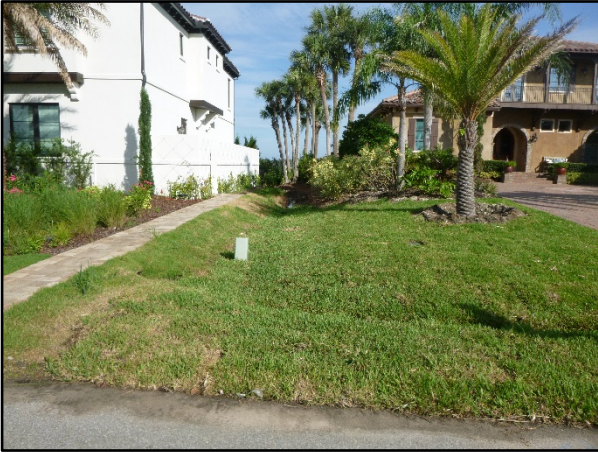
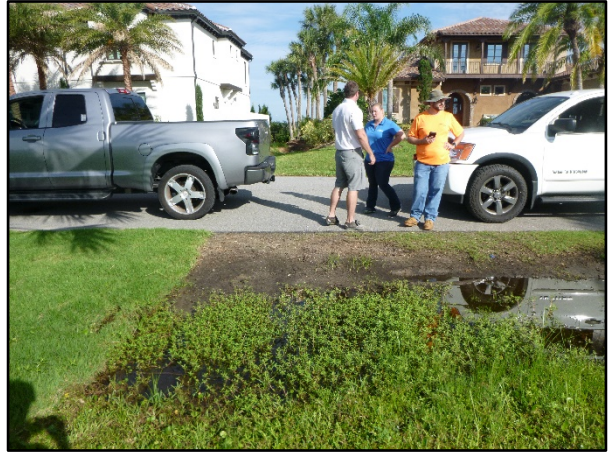
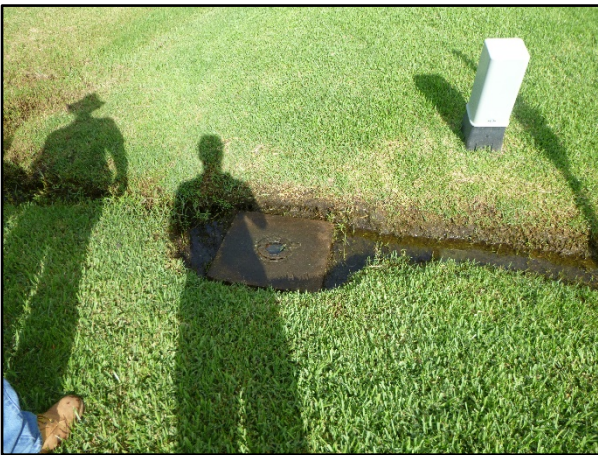
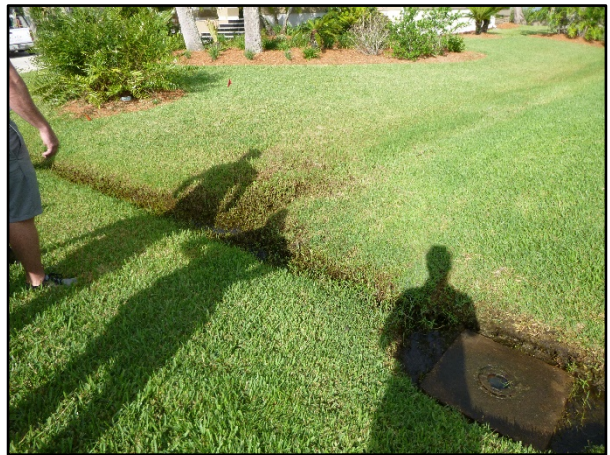
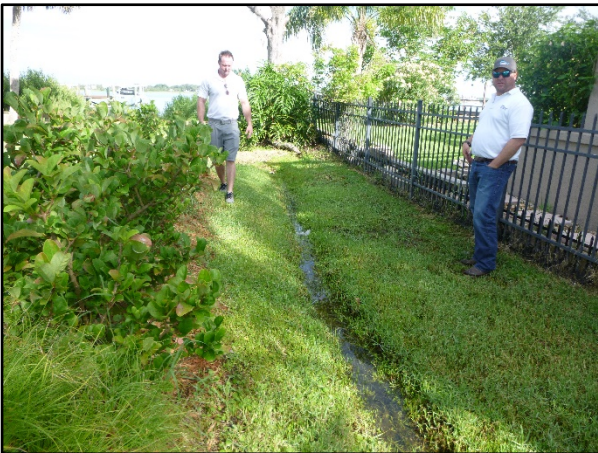
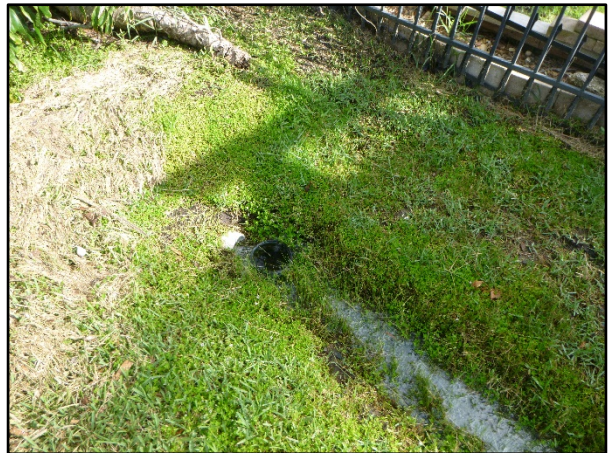
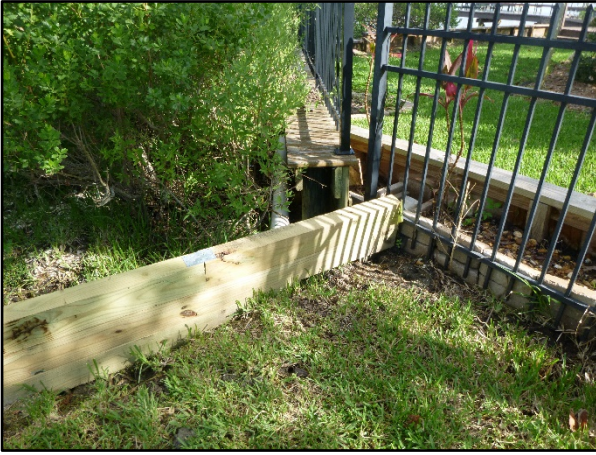
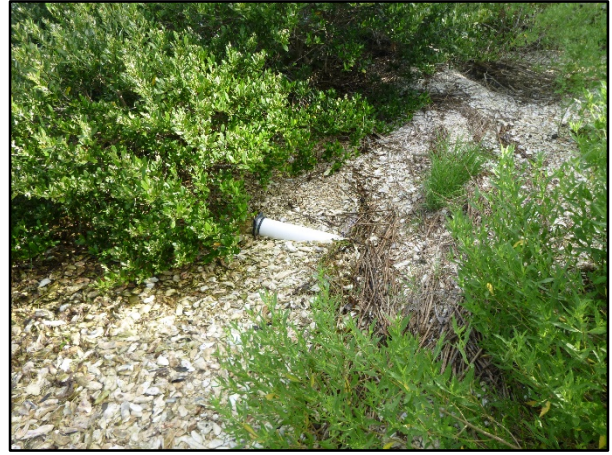
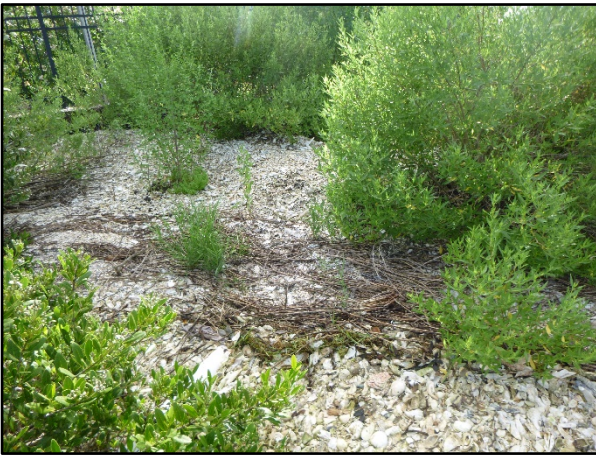
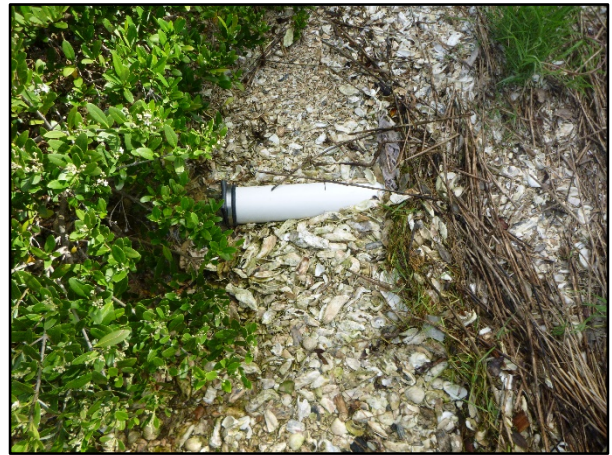
The Drainage Area 4 illustrates the watershed connection to the Matanzas River from Pelican Reef Drive, and is shown in Figure 20. This drainage easement has been blocked with a raise grades, and vegetation, and there are areas with mulch and erosion. There is a box in the middle of the swale by the drain causing drainage issues by blocking swale flow. A pool drains blocked discharge swale, and adds more water to a blocked system.

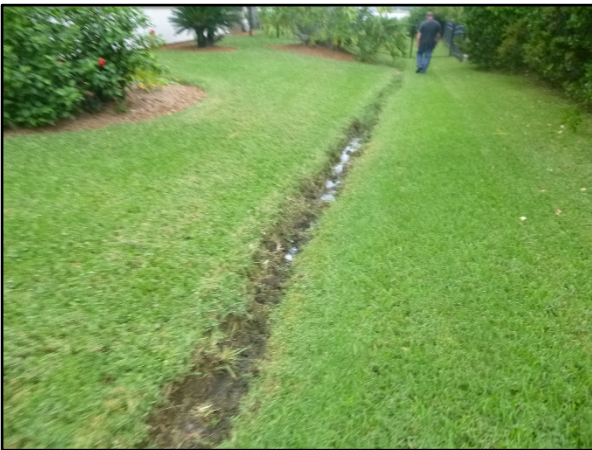
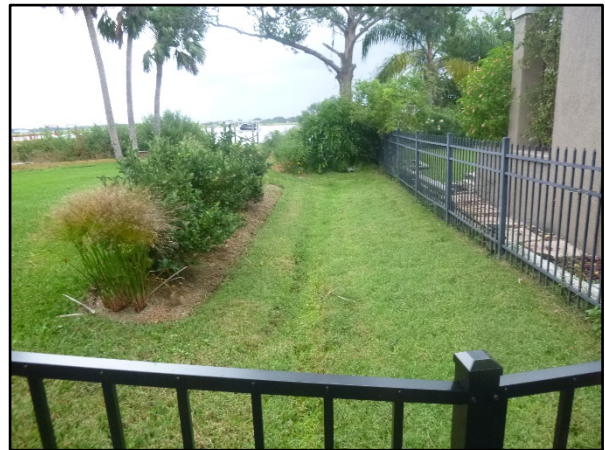
The Drainage Area 6 illustrates the watershed connection to the Matanzas River from Pelican Reef Drive in Figure 34. This drainage easement has been blocked with a raise grades, and vegetation, and there are areas with mulch and erosion.

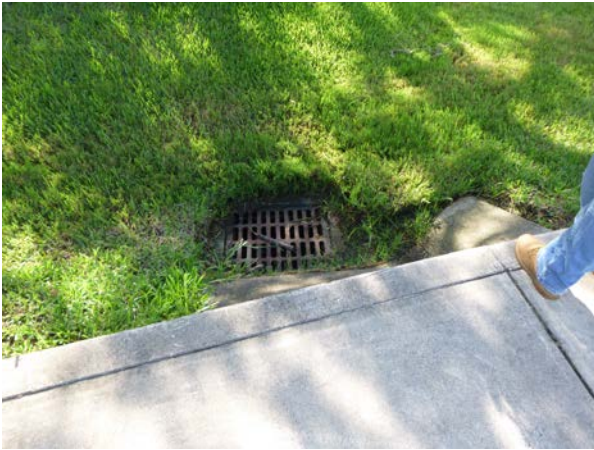
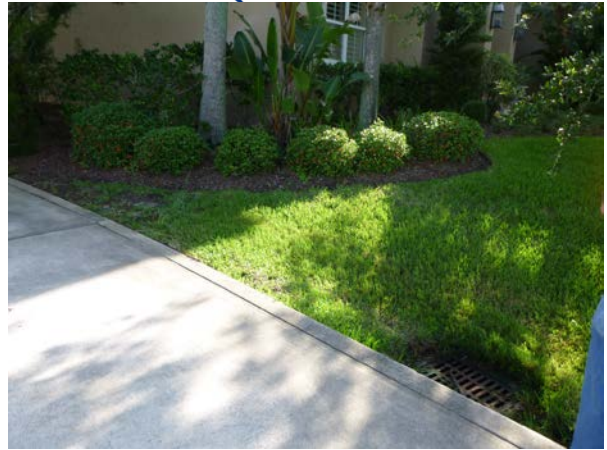
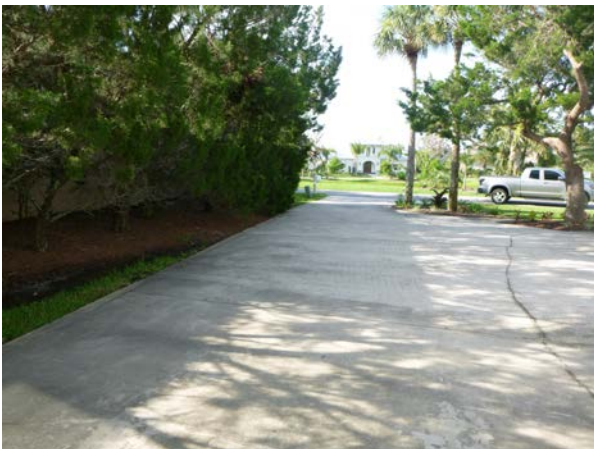
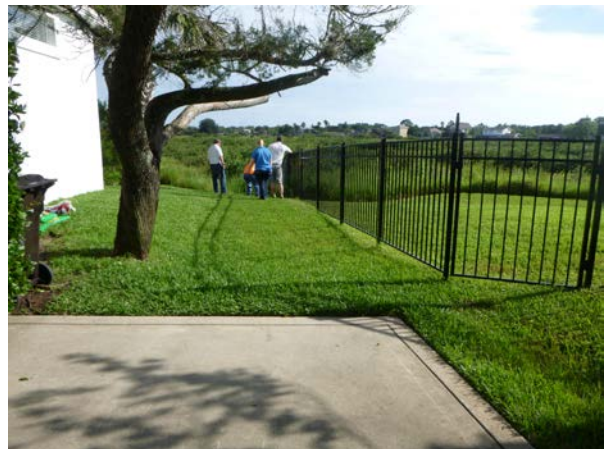
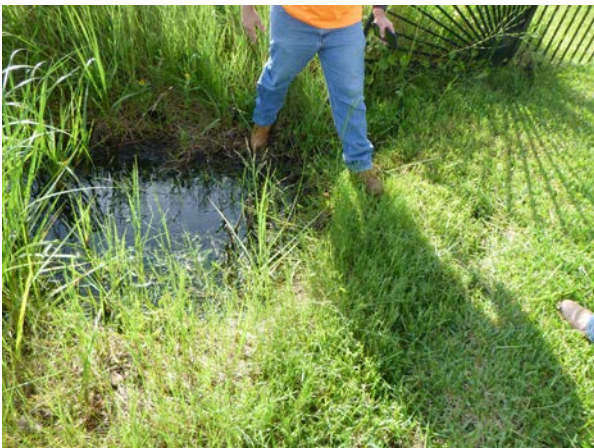
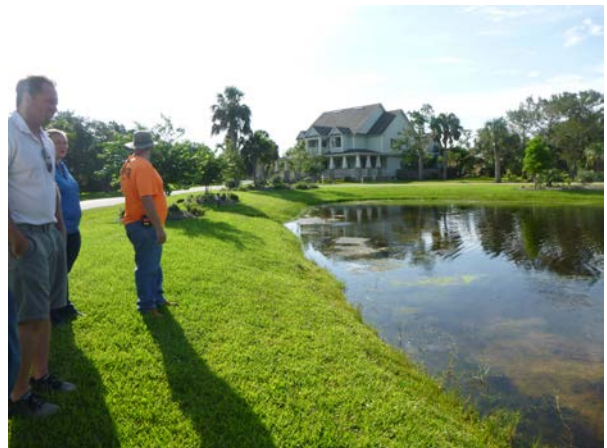
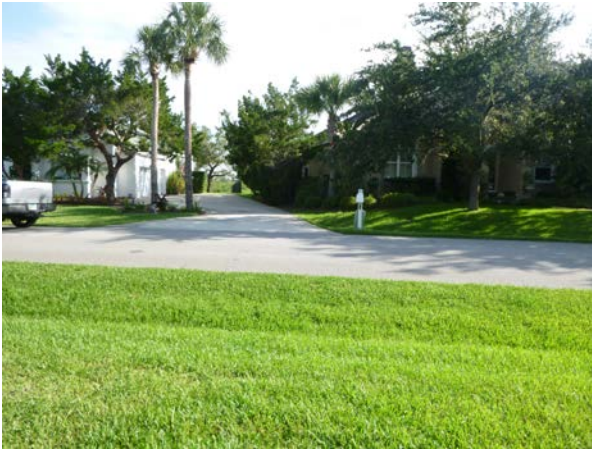
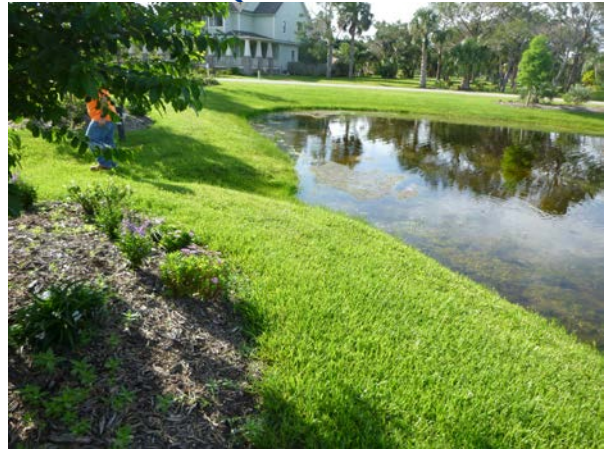
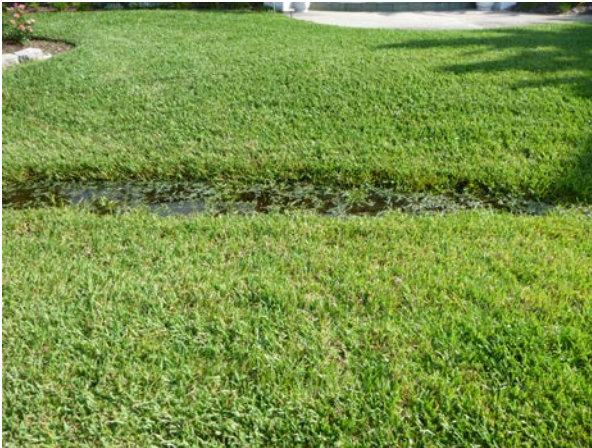
- A. IME Civil, Forest Builders, and Gulfstream Design Group need to get ahold of the sewer detail in location 2.
  - a. The piping at the sewer should not be there according to the approved plans, the whole neighborhood was supposed to have swales and only piping under roads and driveways.
- B. The pipe outfall is in the marsh causing backflow in the storm water system.
  - a. There are large quantities of standing water around the Pelican Reef site and the reason is due to the backflow in the storm water system along with other types of blockages.
- C. IME Civil will need to have a cross section of where the swale dumps into the pond.
- D. Pictures of Location 2:

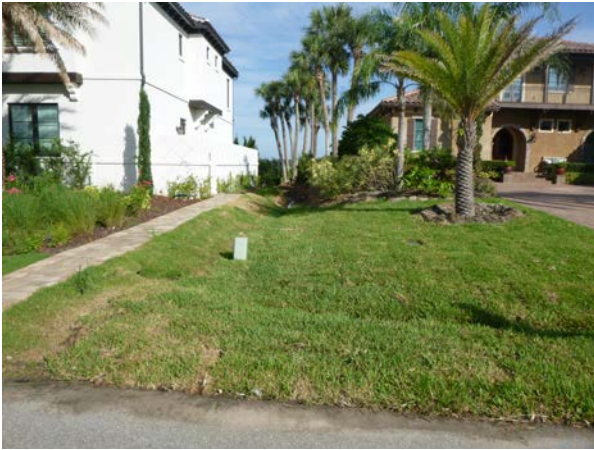
- A. According to the approved set of plans there is supposed to be a pipe under the roadway so any water on the parcel across the street from the marsh can drain to the swale so the water can further drain into the marsh.
- B. Location 3 needs a topographic survey.
- C. Forest Builders wants the land the company is building on marked.
- D. There is an issue with drainage in the swale leading towards the marsh due to trees being inside the swale.
  - a. These trees are to be cleared which will be good for peak storm events.
- E. Everyone in the Pelican Reef subdivision has a grinder pump leading to pressure being low in the area.
- F. Functionality will be restored based on the intent of the originally approved storm water system.
- G. Pictures of Location 3:

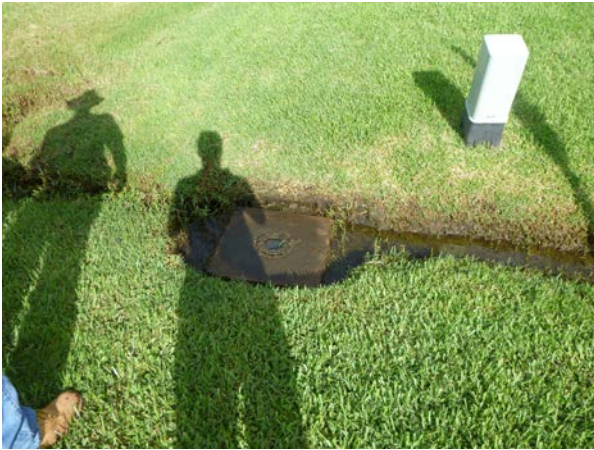
- A. There is a box in the middle of the swale by the drain casing drainage issues by blocking flow.
- B. The water outfall in this location is also to the marsh.
- C. There is an illegal pool drain outfalling into the marsh.
- D. Pictures of Location 4:
