## SITE VISIT MEMORANDUM

**Project #: 18-024 (Pelican Reef)**

**Subject: Present Site Conditions**

**Date: May 10, 2019**

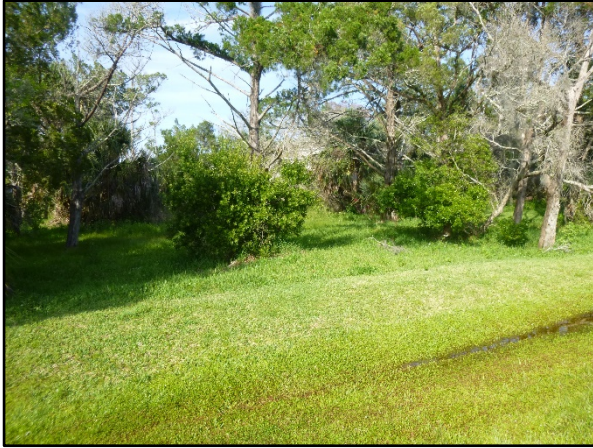
Figure 11: 18-024- 5.6 (11)

- Project area 2 had an observed survey benchmark along the eastern side of Spoonbill Court.
  - This project lies on and within the bounds of “vacant lots”
- Standing water was present within the existing swale.
- A television service box is located to the North of the project site.
- A cable service was flagged in the field to the South of the project site.
- Existing water services (meter boxes) were identified to the South of the site.

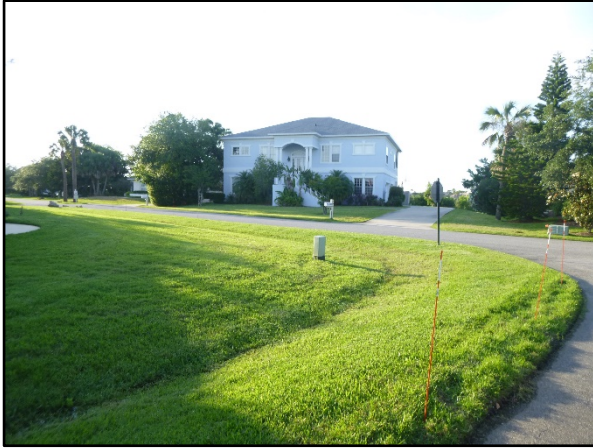
Figure 35: 18-024- 5.6 (35)

- Landscaping encroaches near roadway and could interfere with instillation of storm structures or piping.
- Driveways
  - One concrete driveway and one paver driveway
    - Paver driveway has a (appears) new Mitered end section discharging to the neighboring property. It is not evident whether this drainage is consistently positive. However, during the time of the site visit, there was limited standing water observed in the area.

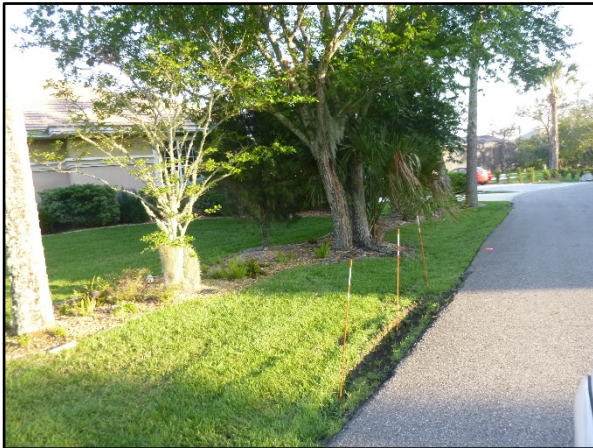
Figure 55: 18-024- 5.6 (55)

- Swale located at the intersection of Oyster Catcher Circle and Spartina Avenue
  - Standing water increases where swale has a depth variance closest to 104 Oyster Catcher Circle mailbox (appears to be an underground pipe discharging improperly)
  - Television service boxes are located outside of the swale, on a developed lot.
- Two separate paver driveway sections (same lot) will need to be removed in order to allow for pipe installation.
  - Underground pipe section is located beneath paver driveway section discharges to a shallow non sodded area with utility service box adjacent.
  - Cable services were identified as being within the project area.
  - Water service (meter box) identified at western end of 110 Oyster Catcher Circle lot.

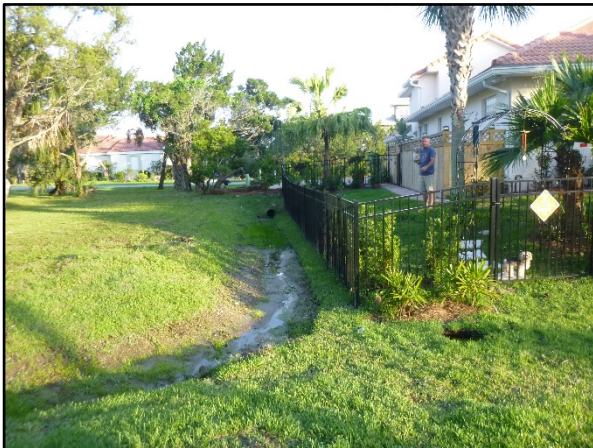
Figure 63: 18-024- 5.6 (63)

- Driveways
  - 3 Driveway sections will need removed and replaced (2 concrete and 1 paver).
    - 2 Existing type “C” inlets are in place adjacent to the paver driveway section.
  - Underground pipe sections discharges do not connect along the North side of Spartina Avenue.
    - This has created standing water in existing swale areas.
- Telephone service boxes were identified adjacent to the driveways.
- As street light pole and power transformer were identified

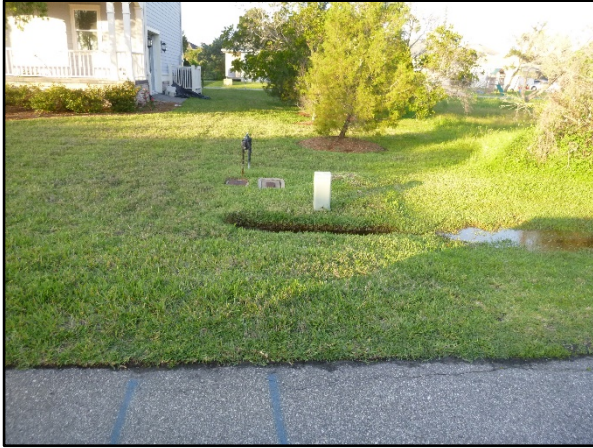
Figure 71: 18-024- 5.6 (71)

- Existing Swale
  - Swale contains standing water
- Project area lies in the bounds of “vacant lots”
- Water services (water meter) identified at the Northern most boundary to the site.

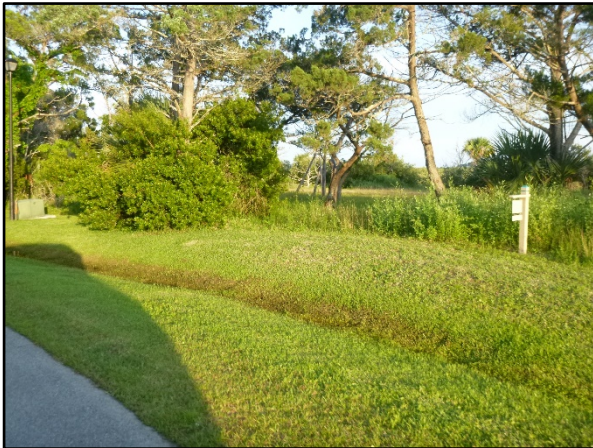
Figure 97: 18-024- 5.6 (97)

### **PROJECT AREA 1 (Pictures 97-104):**

- Existing Swale
  - Existing swale appeared wet with some standing water to the South side of Fiddler Crab Lane.
  - Identified a light pole and power transformer behind the existing swale.
  - Water service identified on the same side of the swale.
  - Specimen trees observed on the same side of the swale as identified utilities
- Lots on the South side of Fiddler Crab Lane
  - All lots on this side of the road are currently considered vacant.
